BPG Inspection, LLC

**12849 Palm Drive
Largo FL 33774**

Client(s): Stone
Inspection Date: 8/30/2022
Inspector: David Batha , HI8000 (FL)

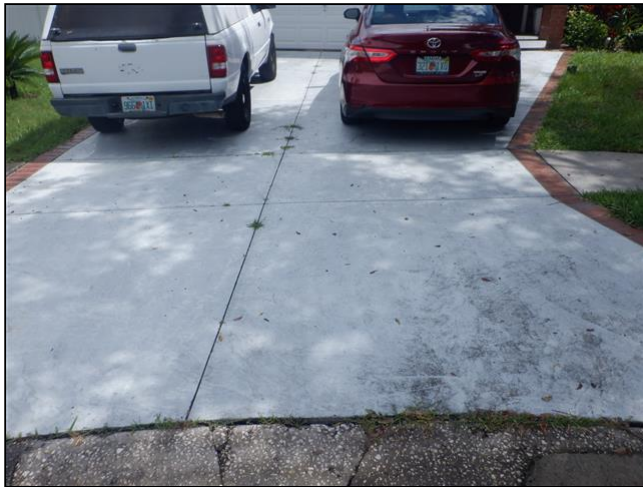
Driveway

- ◆ Except for typical hairline cracks, the driveway, walkways and patio(s) showed no visible signs of any deficiencies on the day of the inspection.

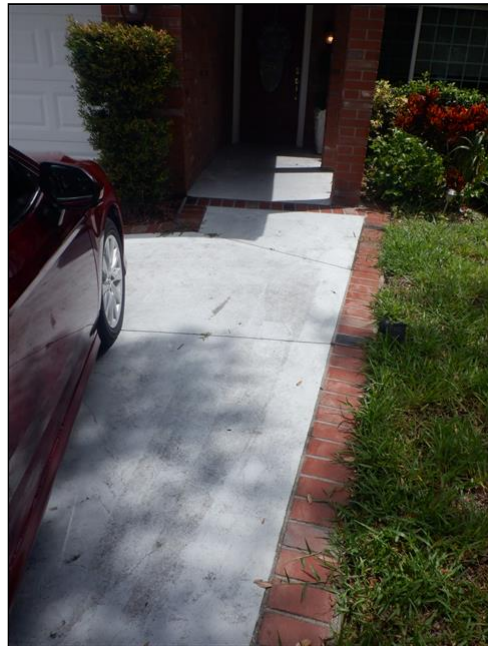
Front Walk

- ◆ There were common cracks and typical settlement in the concrete flat work observed on the property. All concrete flat work is intact and functional.

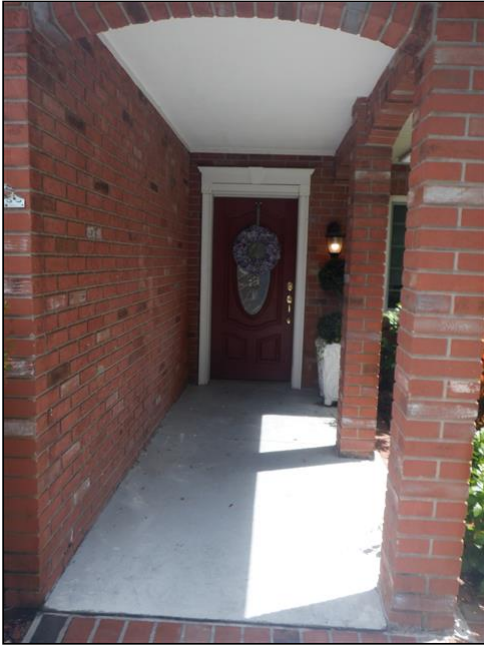
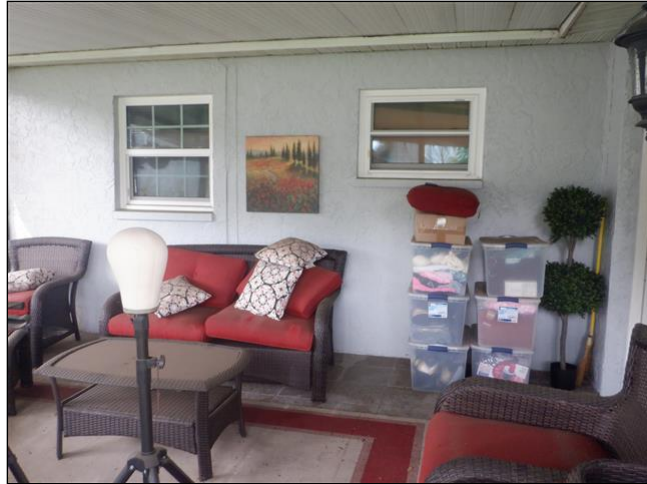
- ◆ The porch, patio and balcony (if applicable) structures showed no signs of any deficiencies at the time of inspection.

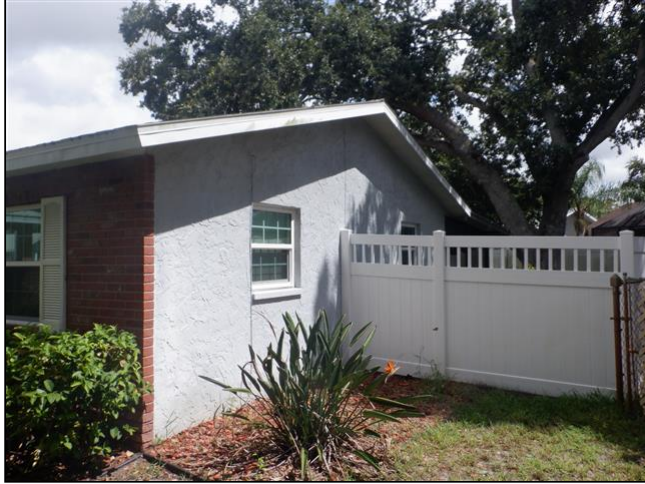
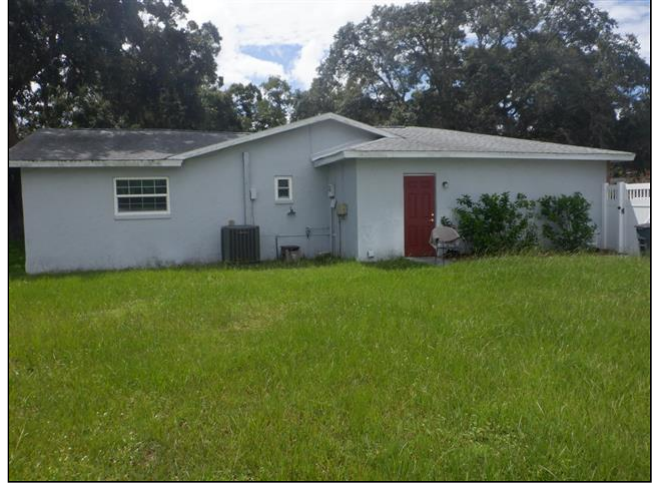
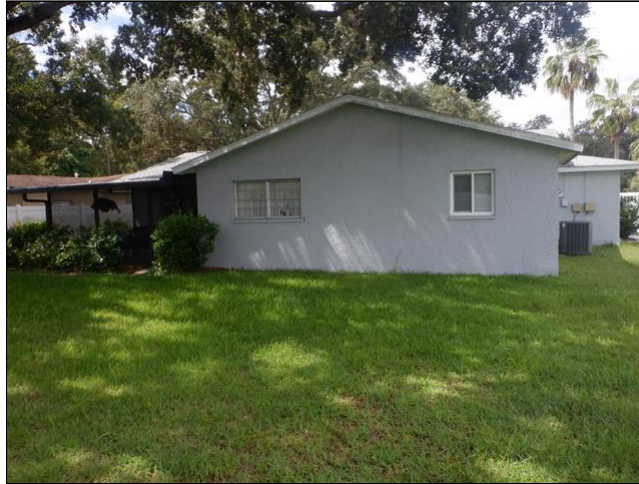
- ♦ The exterior cladding as described in the Styles & Materials section showed no visible defects and exhibits normal wear based on the age of this home.
- ♦ Finishes at the exterior are failing. Refinishing is recommended.

- 1 Finishes at the exterior are failing. Refinishing is recommended.

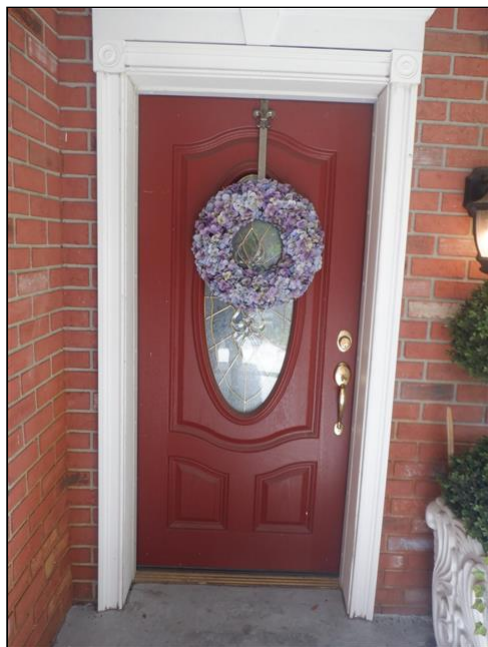
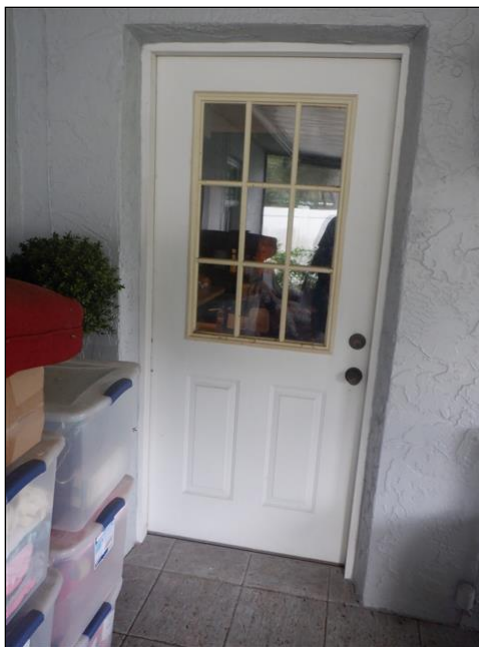
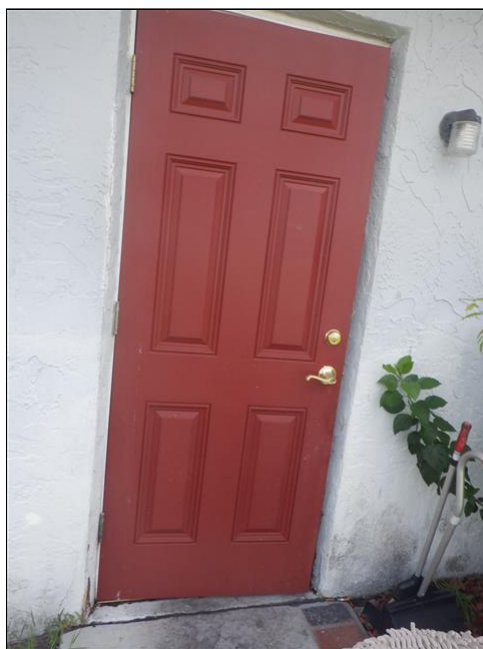
- ◆ The exterior doors showed no signs of any defects on the day of the inspection.

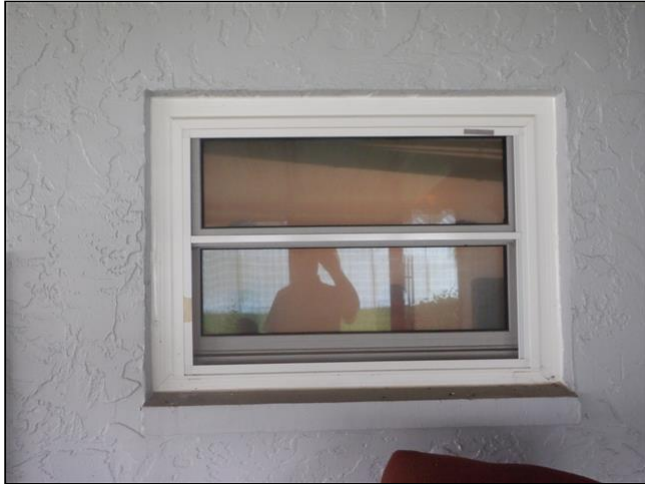
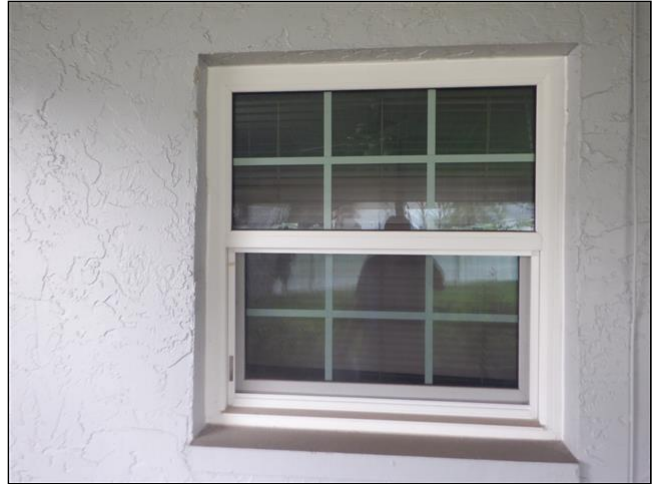
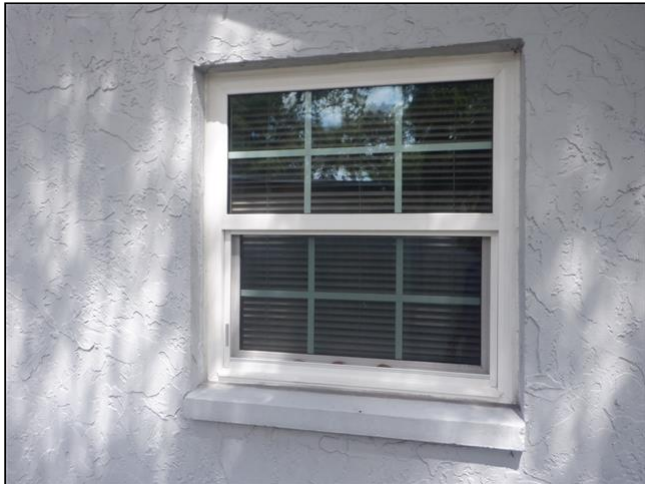
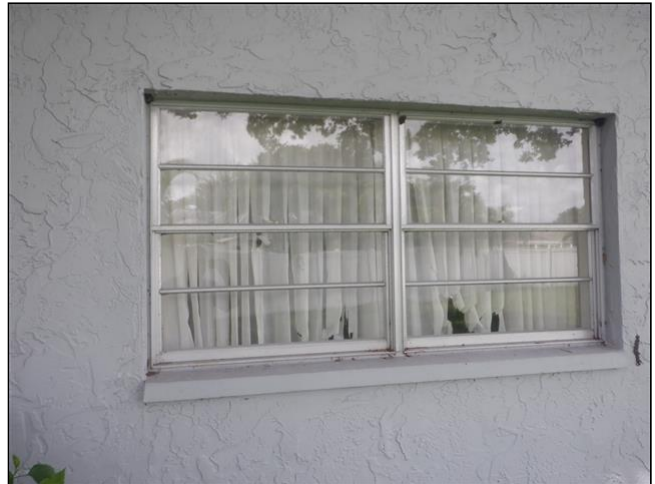
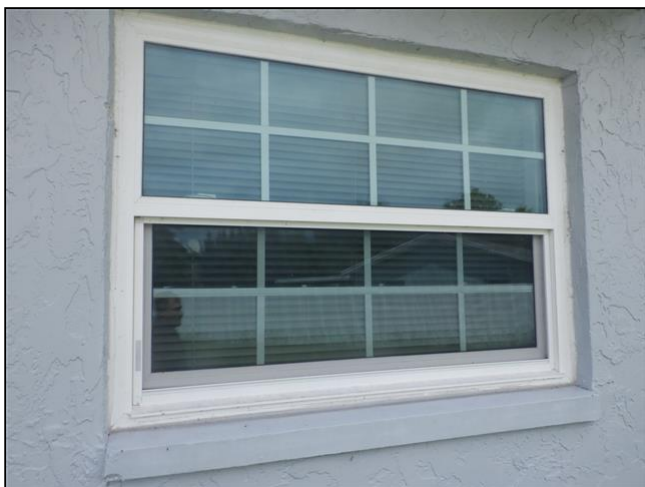
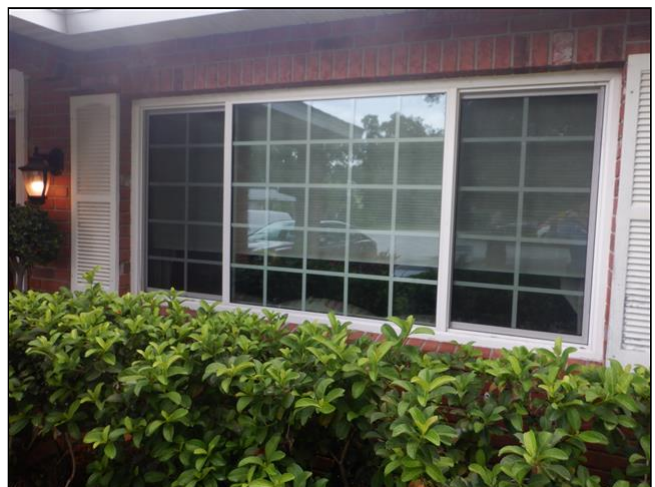
- ◆ The exterior side of the windows showed no signs of any deficiencies on the day of the inspection.

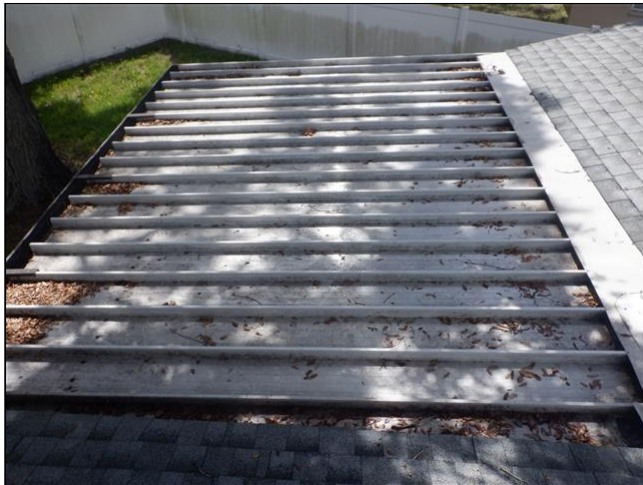
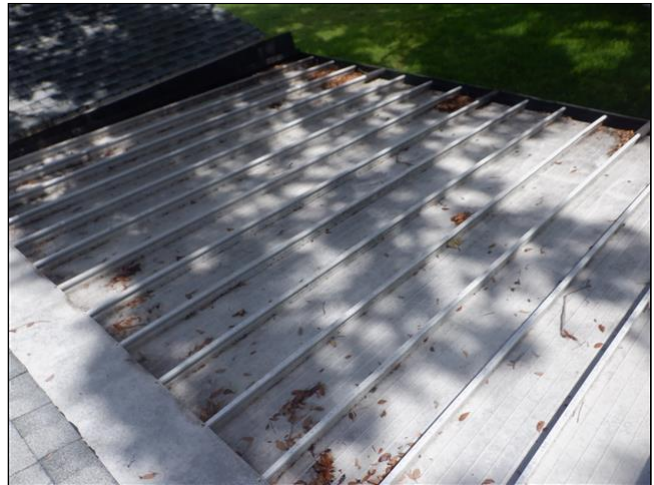
- ◆ The back patio roof coverings showed no visible signs of any deficiencies on the day of the inspection.

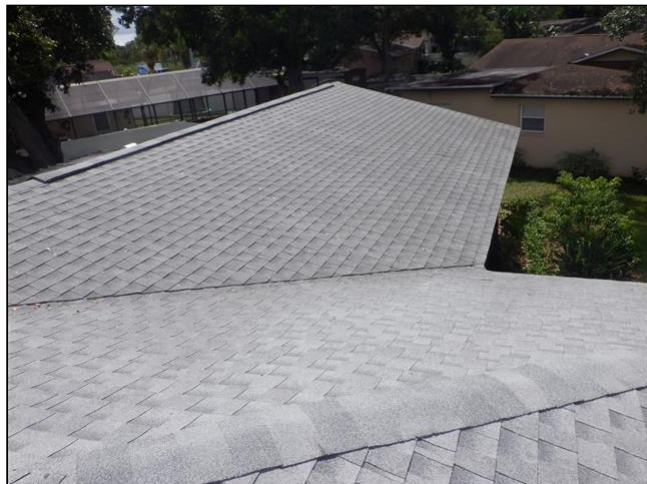
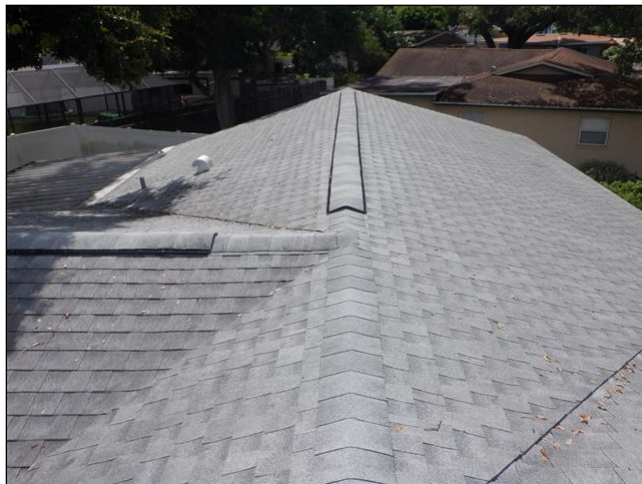
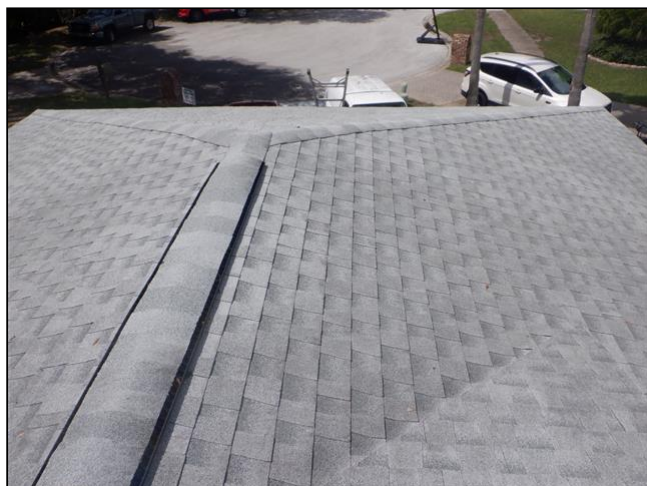
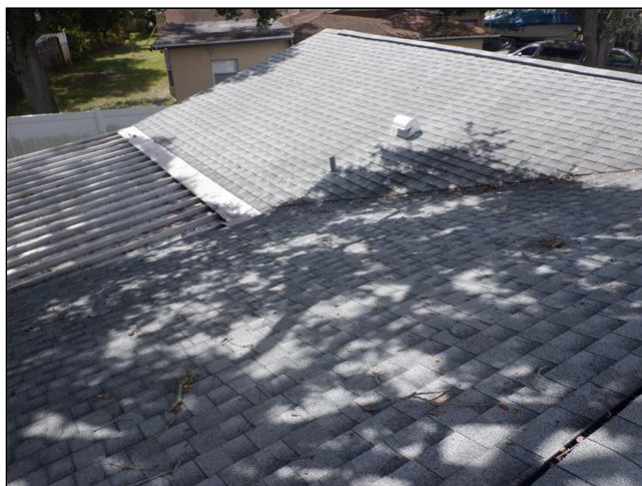
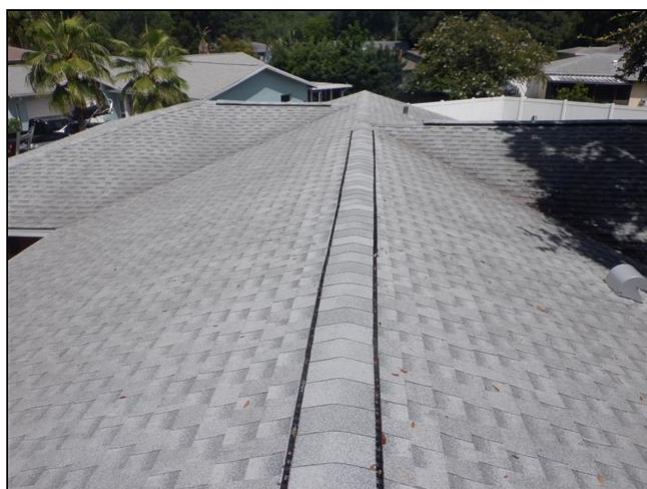
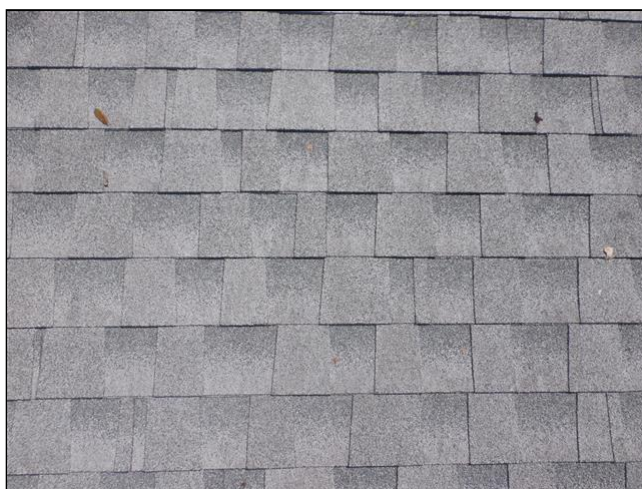
- ◆ A composition shingle roof system was installed over the majority of the structure. This type of shingle is composed of an asphalt impregnated fiberglass mat covered with a granular aggregate and come in dimensional or Architectural style. The latter type of shingle is considered to be the 'premier' composition shingle with a manufacture estimated life span approximately five to ten years longer than the typical dimensional shingles. The roof appears to be in the first third of its useful life. Periodic maintenance will extend the life of this roof covering.

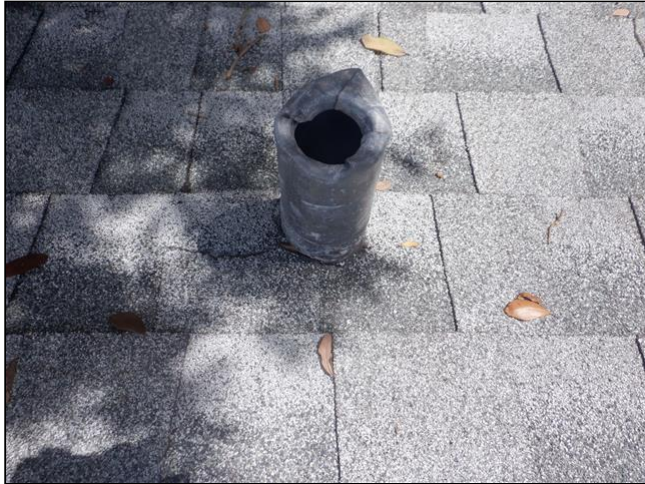
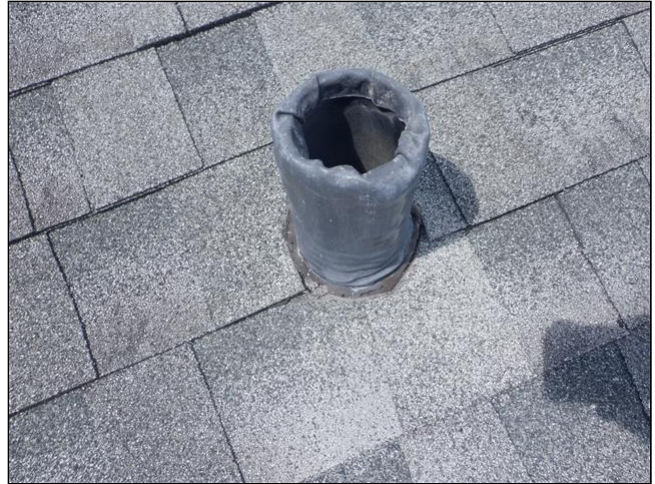
- ◆ All visible flashing materials showed no signs of any deficiencies on the day of the inspection.

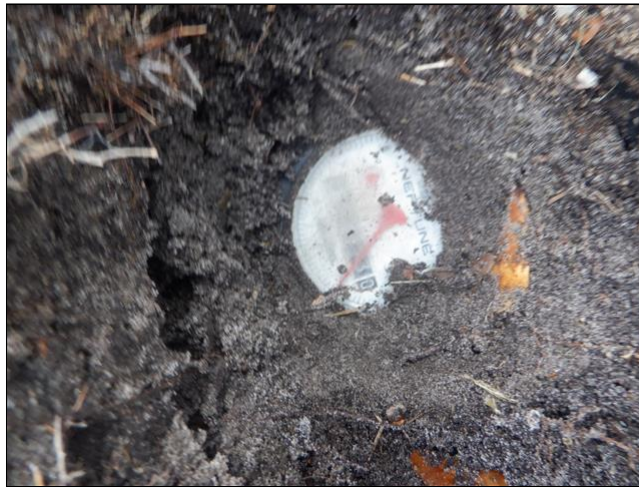
Water Meter

- ✘ ◆ We were unable to locate a main water service shut-off valve except the service valve at the meter. This makes it difficult at best to shut off the water service in an emergency. In order to bring the house to acceptable building standards an accessible shut off valve should be located at the water main line at the house.

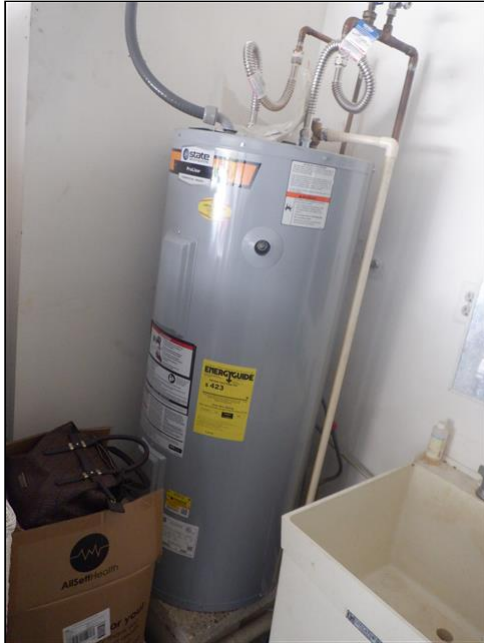
Water heater

- ◆ The design of electric water heaters does not lend itself to internal inspection. We cannot estimate its life expectancy. The water heater was intact and functional at time of inspection. NOTE: The normal useful life of most water heating systems is 8 to 10 years.

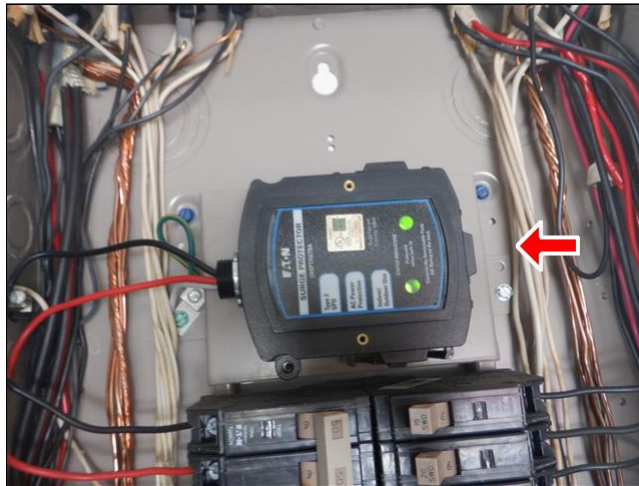
- ✘ ◆ The electrical system of this home is equipped with a Load Controller provided by the local utility. Determining the efficiency of or operating the Load Controller is not within the inspection scope. Ask the seller to explain this device or consult your local electric utility.

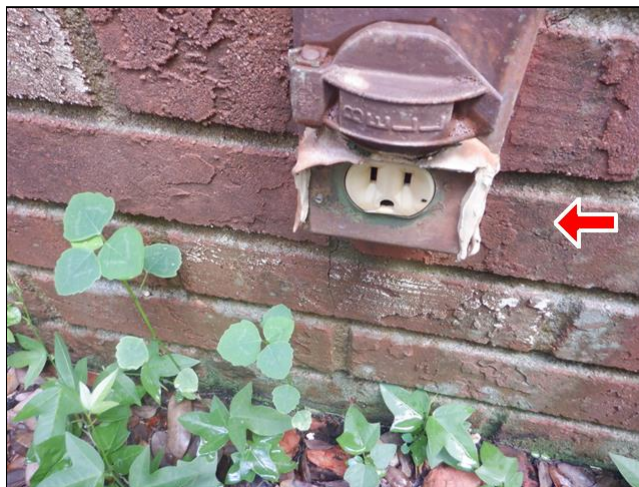
Building exterior

- ✘ ◆ The weather resistant outlet cover at the front of the home is damaged or missing, repair or replace as needed.

- 4 The weather resistant outlet cover at the front of the home is damaged or missing, repair or replace as needed.

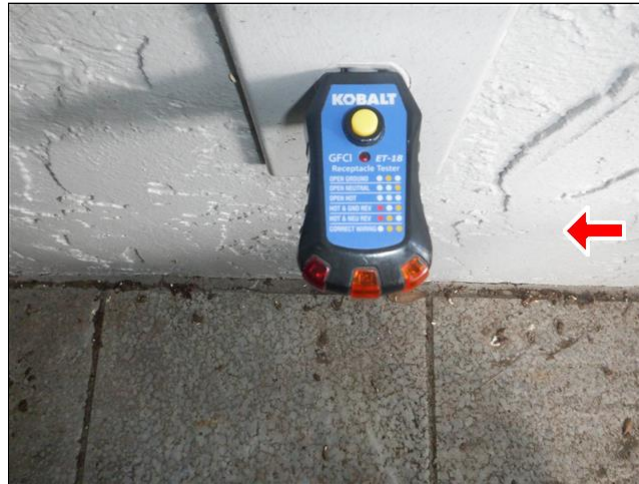
Building exterior

- ✘ ◆ Exterior receptacle(s) at the rear of the building has no power. A qualified technician could evaluate the receptacle and make repairs or modifications as necessary.

- 5 Exterior receptacle(s) at the rear of the building has no power. A qualified technician could evaluate the receptacle and make repairs or modifications as necessary.

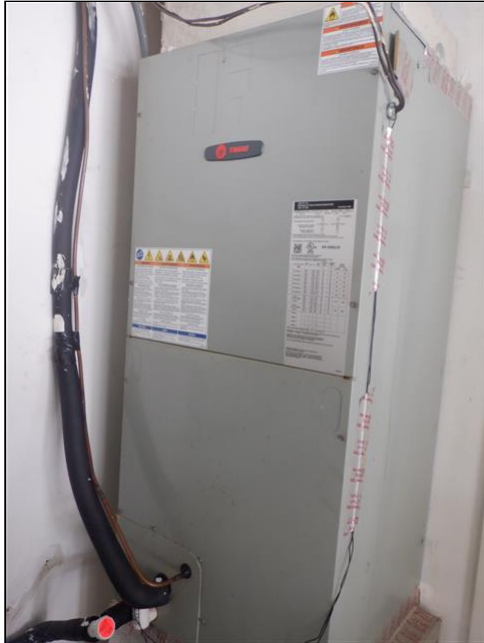
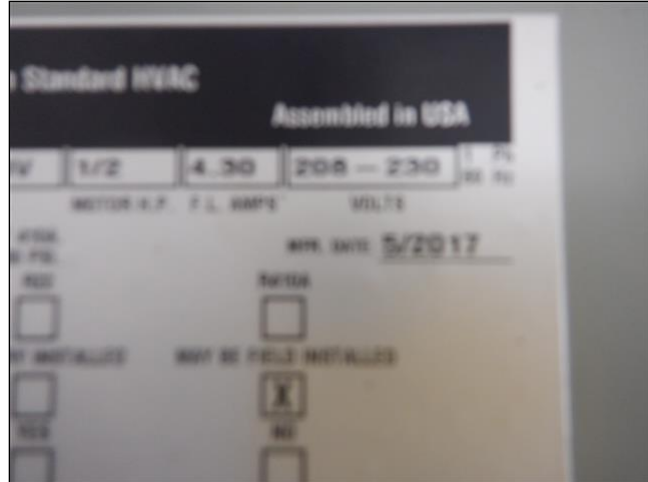
- ◆ The air handler is located in the garage. The air handler is approximately 5 years old.

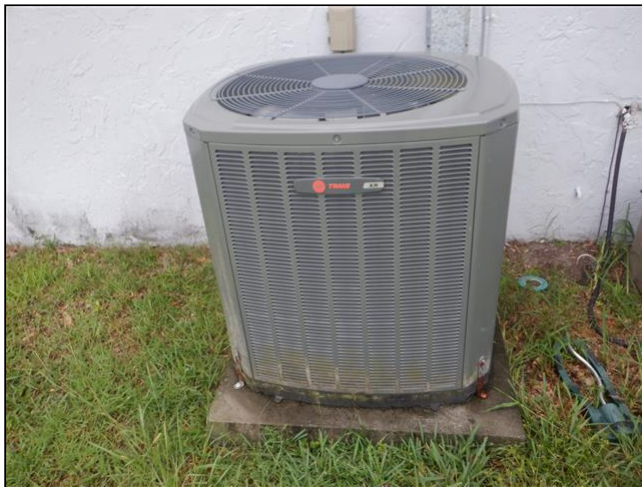
Condensing Unit

- ◆ Air Conditioning Unit is located at the left side. The capacity of the unit is approximately three tons. The age of the unit is 5 years old as determined by the data plate.

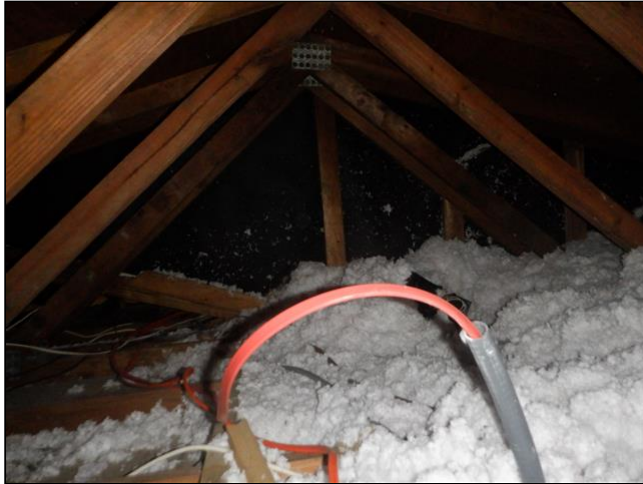
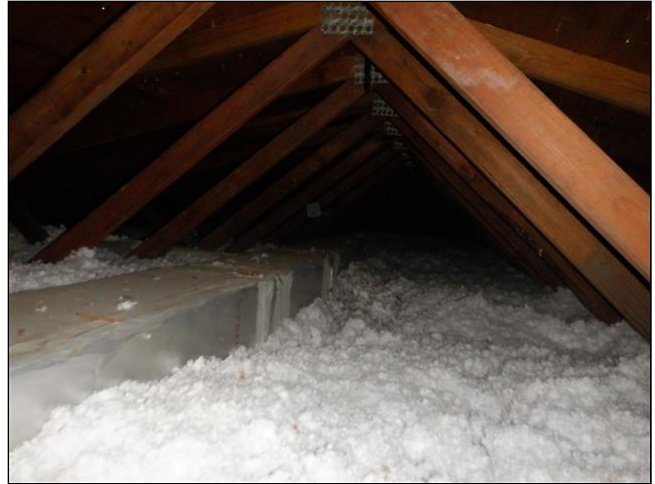
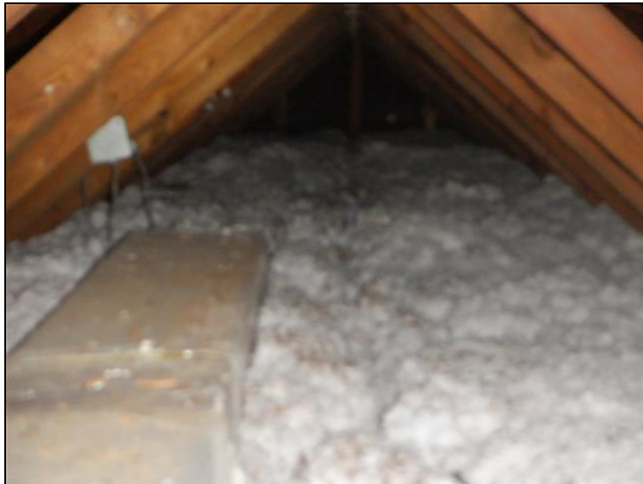
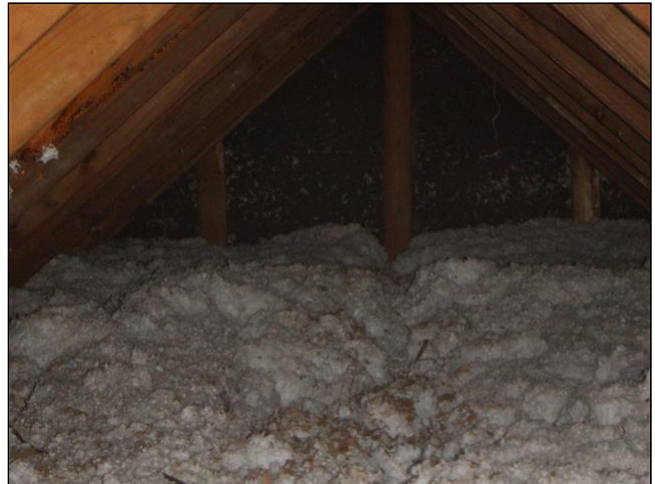
- ◆ The photos show the areas in the attic that were accessible to your inspector, these areas when reviewed showed no signs of any deficiencies on the day of the inspection.

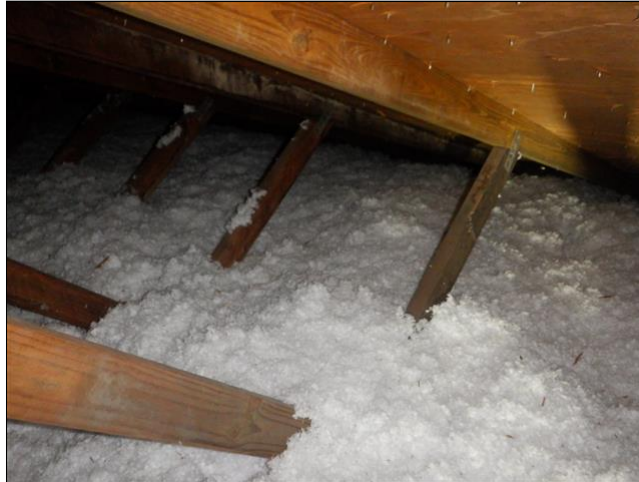
Photos of Attic Space

- ◆ The depth of the attic insulation meets or exceeds current standards where your Inspector measured it at several locations. Please note that within reason, most attics benefit from added insulation.

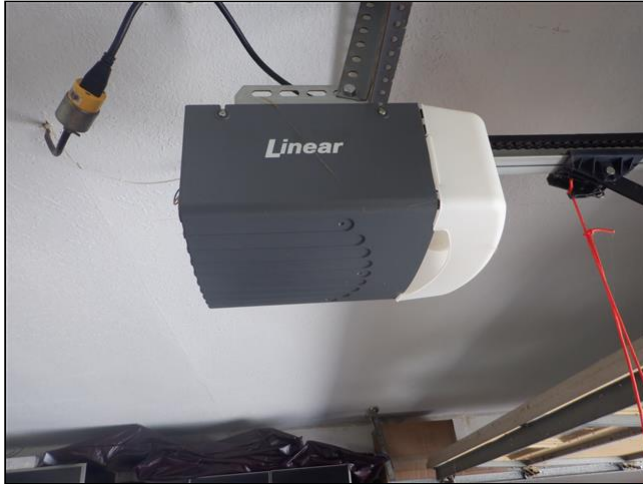
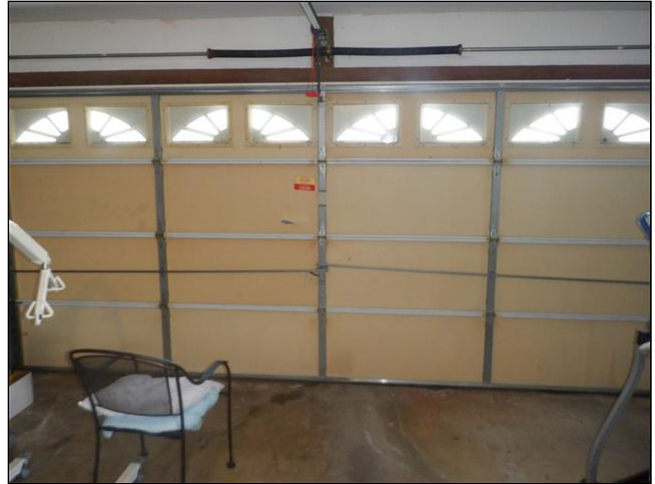
- ✘ ◆ The garage door opener raised and lowered the door, and it stopped and reversed when the light beam was interrupted. However, it did not stop or reverse when meeting resistance. Typically, this condition can be remedied by a simple adjustment of the door sensitivity. The sensitivity on the closing (downward) force exerted by the opener mechanism should be adjusted to a safe level.

- 6 The garage door opener raised and lowered the door, and it stopped and reversed when the light beam was interrupted. However, it did not stop or reverse when meeting resistance. Typically, this condition can be remedied by a simple adjustment of the door sensitivity. The sensitivity on the closing (downward) force exerted by the opener mechanism should be adjusted to a safe level.

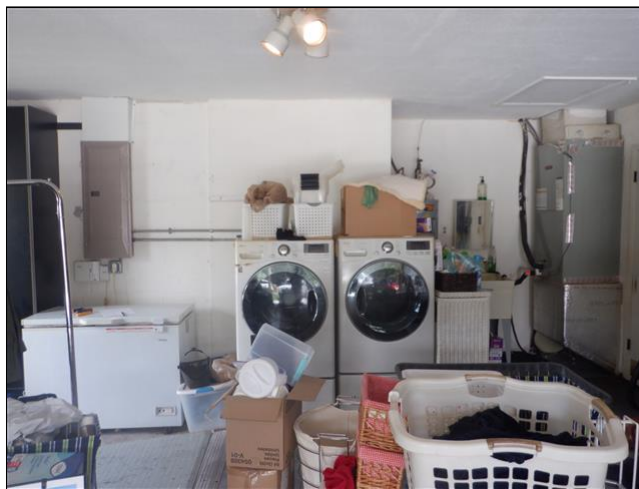
Garage Interior

- ◆ The fire rated assembly was intact with no visible holes and or defects noted on the day of the inspection.

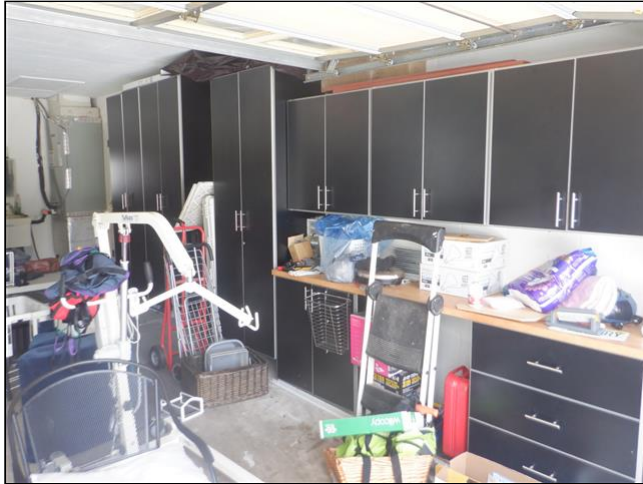
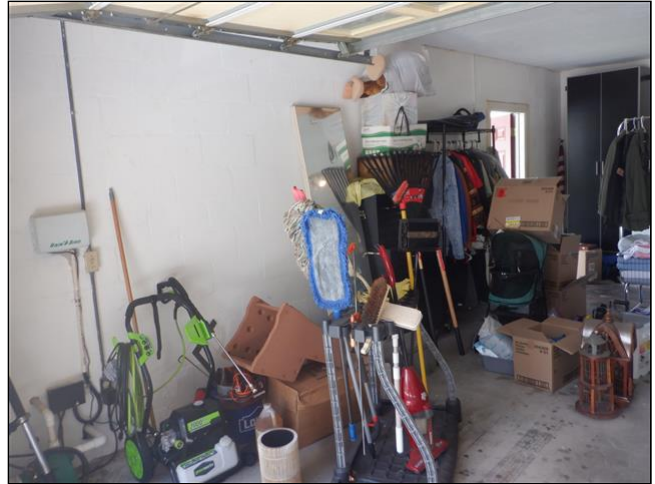
- ◆ The garage walls and ceilings were intact and functional where they could be viewed. Typical cosmetic cracks / wear and tear for age of home.

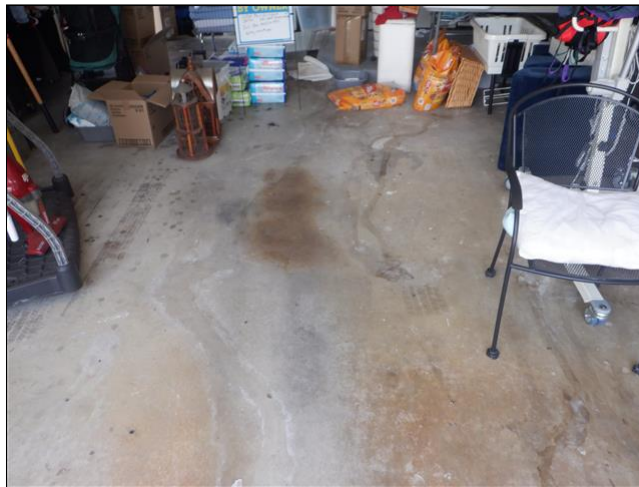
Garage Interior

- ◆ The garage floor (where visible) was intact and functional. No major defects were visible at time of inspection.

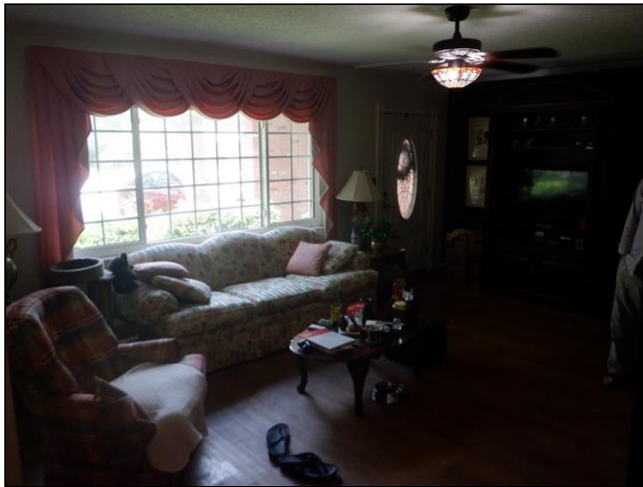
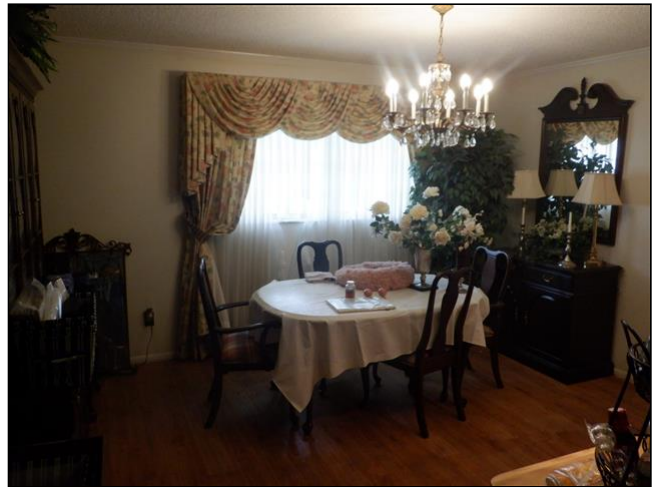
Building Interior Rooms

- ◆ The interior wall, floor, and ceiling surfaces are generally in adequate condition, taking into consideration normal wear and tear.

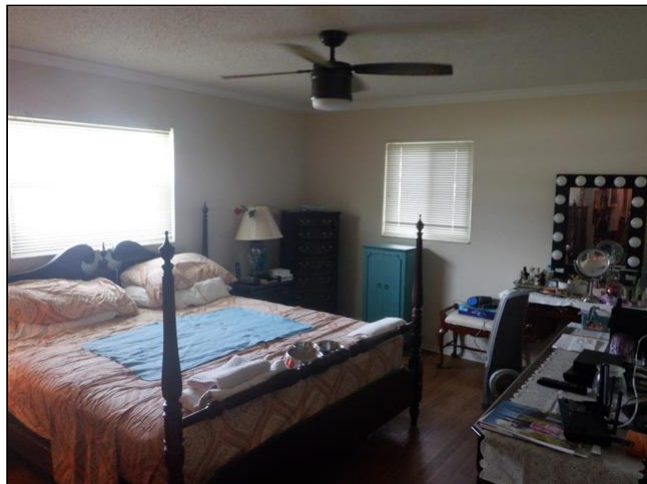
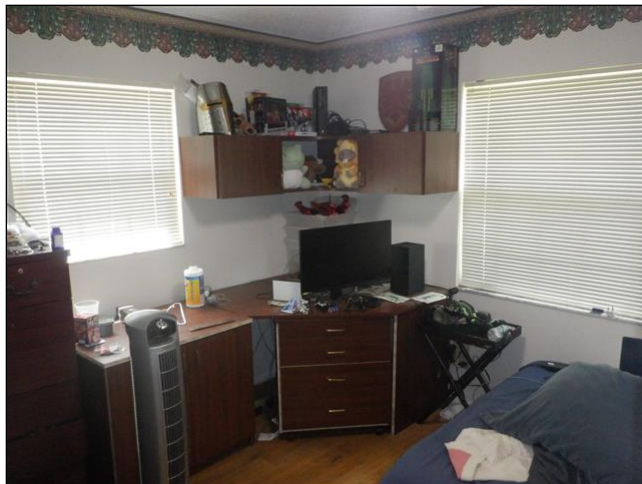
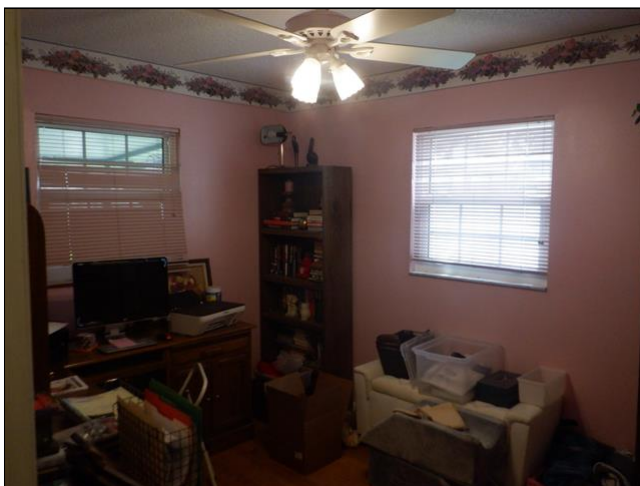
Building Interior Rooms

- ◆ Minor cracks are evident in the walls and / or ceilings. This is a common condition with this type of construction and, in this case, does not indicate any structural concerns. The cracks can be repaired or painted during routine maintenance. Other than these cosmetic issues the walls and ceilings were in acceptable condition

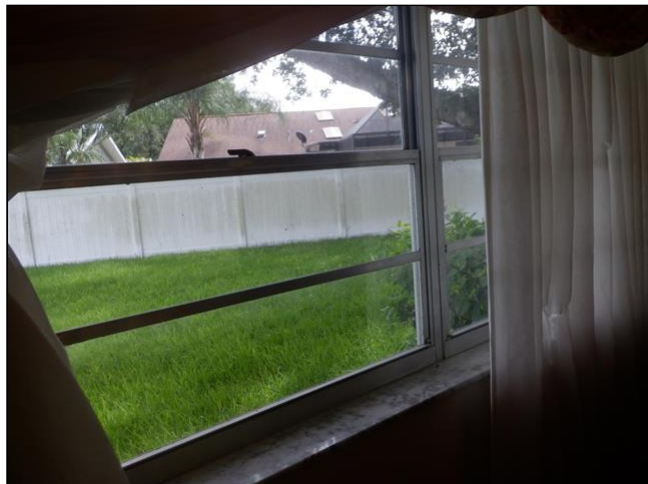
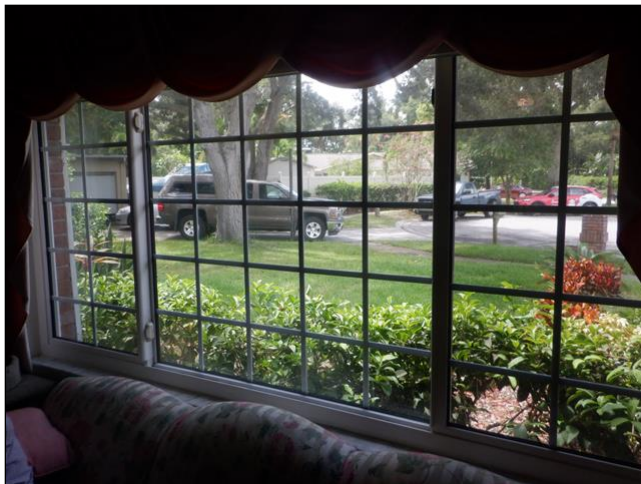
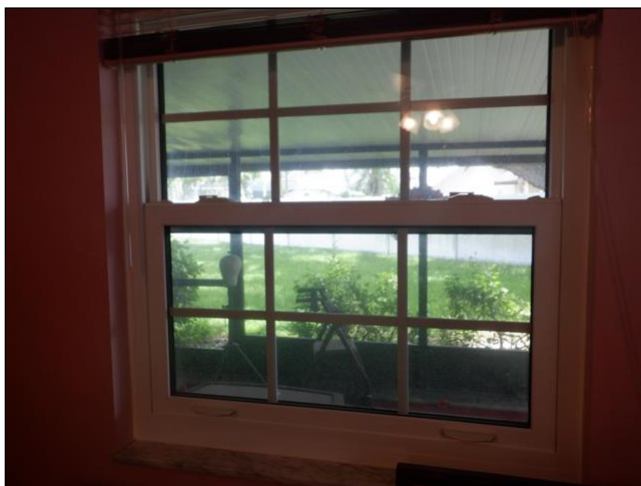
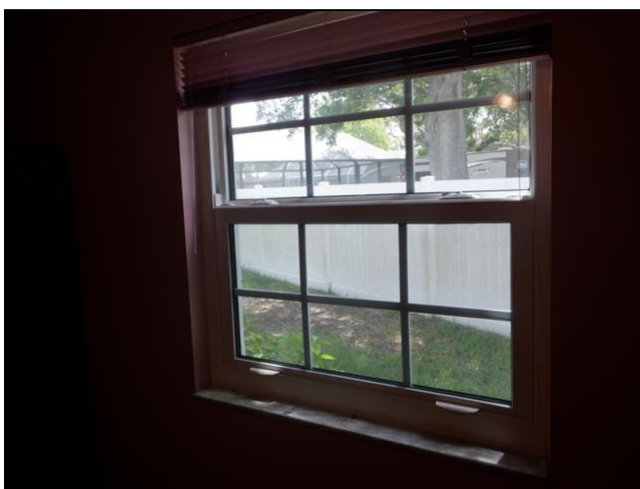
Building Interior Rooms

- ◆ The interior windows showed no signs of any deficiencies on the day of the inspection. Note that identifying damaged thermal seals can be difficult if not impossible on any given day.

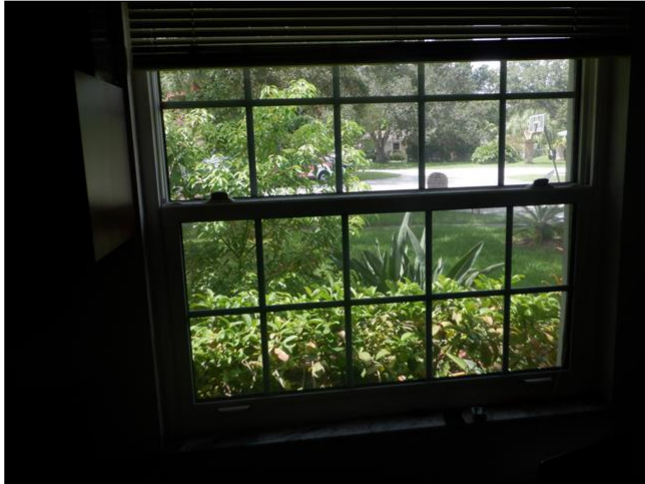
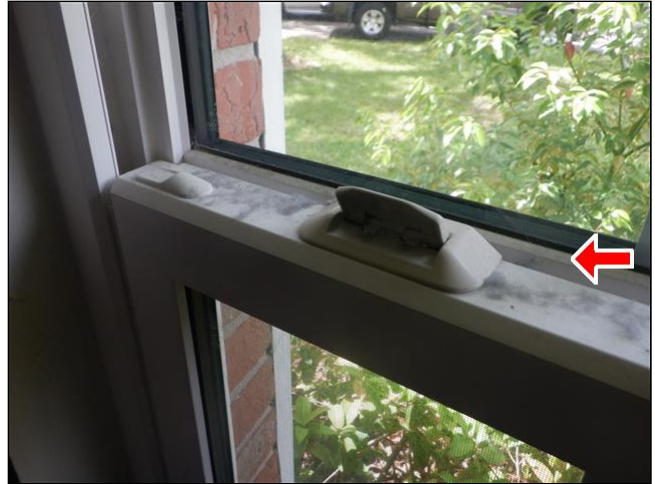
♦ There is a broken / missing or inoperable latch at a window in a bedroom .Replace affected latches as needed.

- 8 There is a broken / missing or inoperable latch at a window in a bedroom .Replace affected latches as needed.

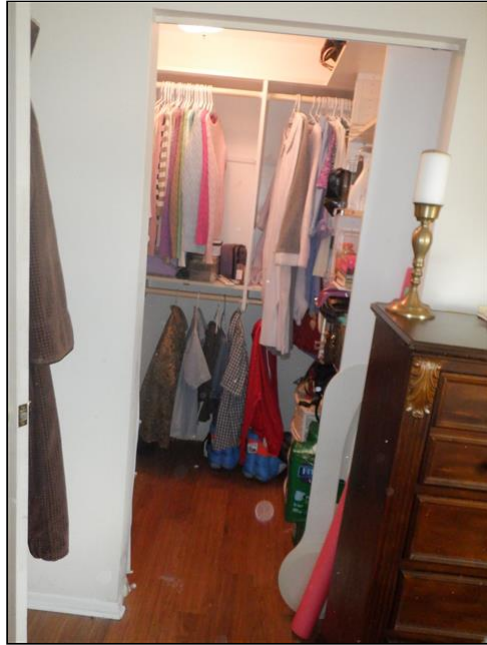
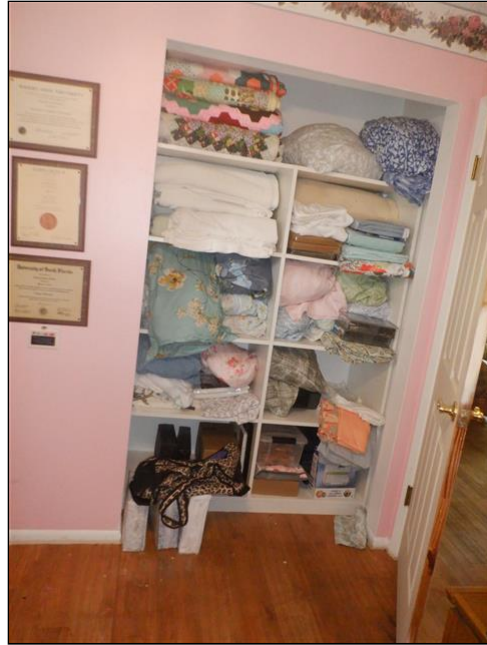
- ◆ A door in a bedroom closets has been removed. All removed doors should be re-hung in their original locations as needed.

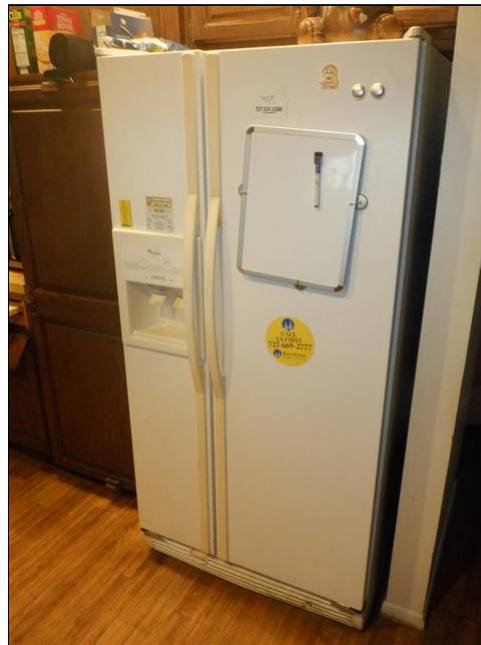
Kitchen Area

- ◆ The refrigerator and related equipment were not evaluated and is specifically excluded from this report.

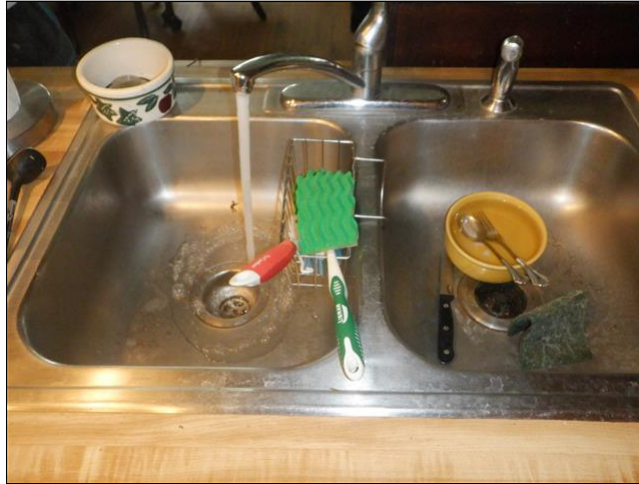
Kitchen Area

- ◆ The kitchen sink(s) and visible plumbing exhibit typical wear and tear normal for this heavily used component. The flaws are cosmetic in nature. No remedial action is indicated.

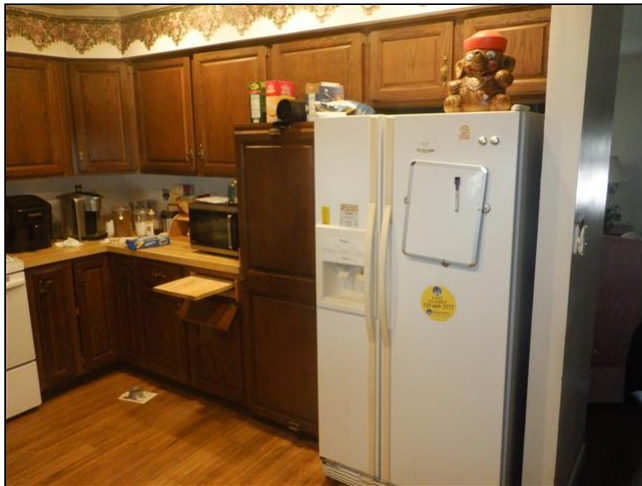
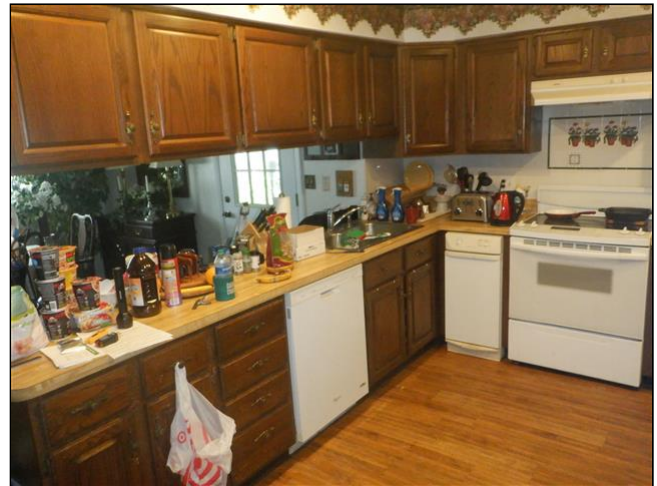
- ✦ The countertop and cabinets in the kitchen are deteriorated. This affects its appearance, and may limit its remaining useful life.

- 14 The countertop and cabinets in the kitchen are deteriorated. This affects its appearance, and may limit its remaining useful life.

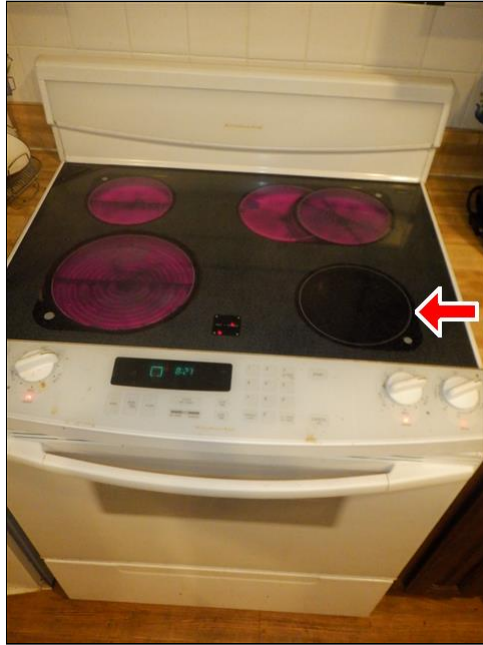
Kitchen Area

- ✦ The right front burner did not respond when tested. I recommend having a qualified appliance technician make further evaluations and repairs as needed.

- 10 The right front burner did not respond when tested. I recommend having a qualified appliance technician make further evaluations and repairs as needed.
- 11 The oven failed to respond to normal operating controls. A qualified appliance technician could make repairs or modifications as necessary.

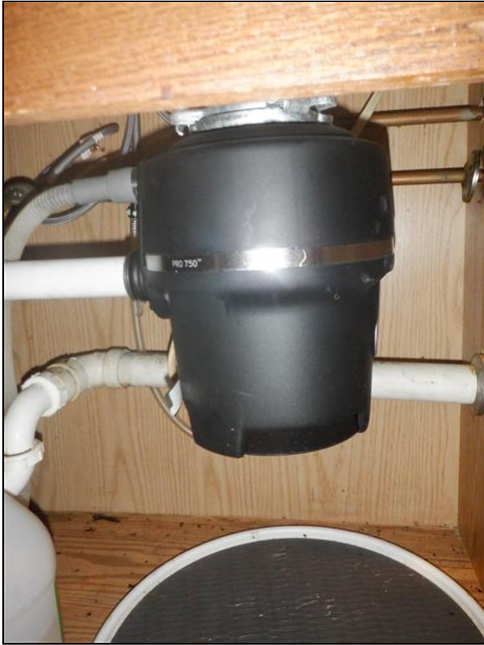
Disposal

- ❌ ♦ The wiring is not protected in a conduit at the disposal. No bare, exposed metal wiring should be visible under the sink, nor wire splices, any of which could be a shock hazard. Have an electrician make repairs.

- 12 The wiring is not protected in a conduit at the disposal. No bare, exposed metal wiring should be visible under the sink, nor wire splices, any of which could be a shock hazard. Have an electrician make repairs.

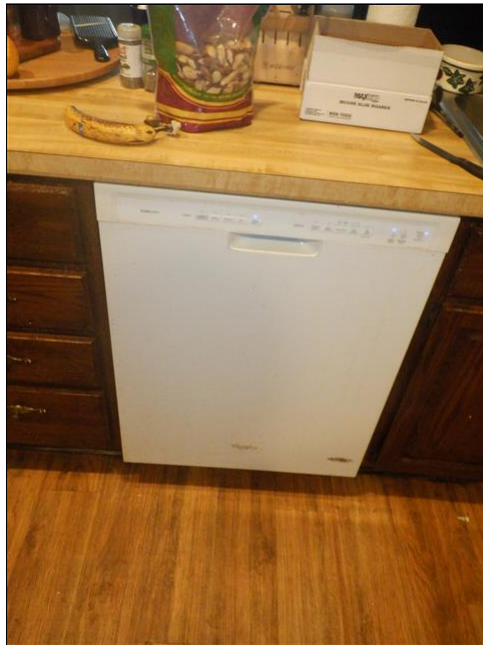
Kitchen Area

- ◆ During the inspection of the Dishwasher we only check the running cycles, Physical parts visible and the draining system. Checking of the Drying system is beyond the scope of this inspection.No leaks noted at time of inspection.

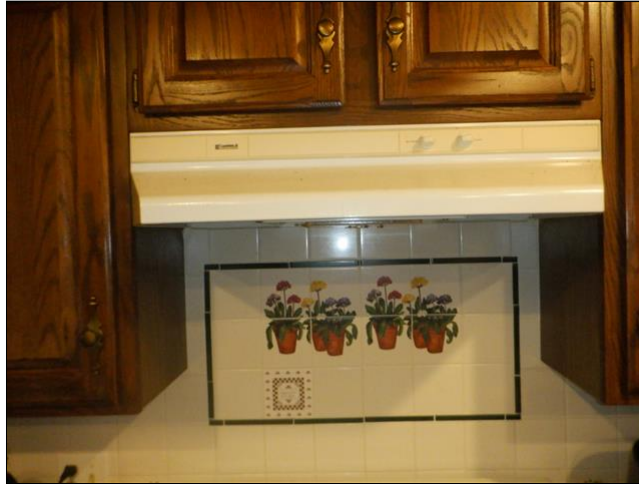
Kitchen Area

- ◆ The kitchen cooking vent system performed its intended function on the day of the inspection.
