BPG Inspection, LLC

**12849 Palm Drive
Largo FL 33774**

Client(s): Stone
Inspection Date: 8/30/2022
Inspector: David Batha , HI8000 (FL)

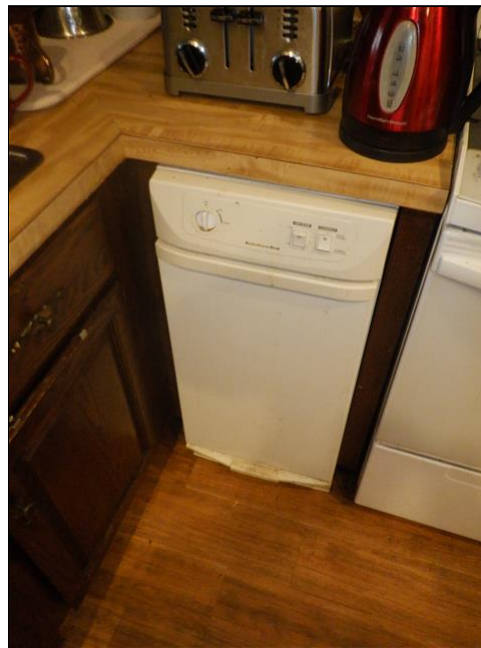
Kitchen Area

♦ The trash compactor did not operate through the control switch. This appliance is old and in replacement condition.

- 13 The trash compactor did not operate through the control switch. This appliance is old and in replacement condition.

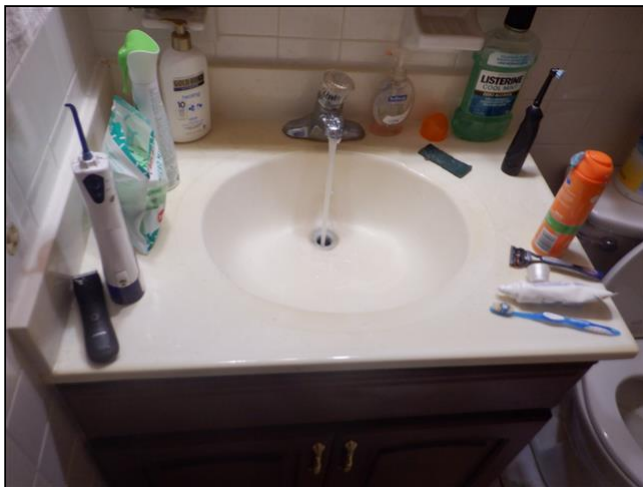
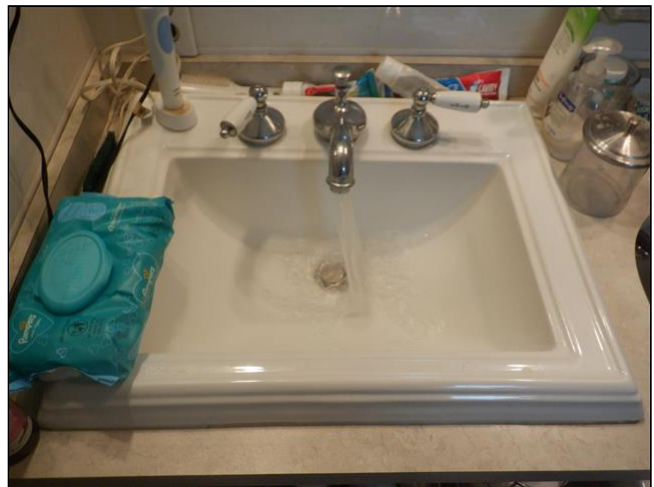
Hallway Bathroom

- ◆ No leaks and or deficiencies associated with the bathroom sinks were visible on the day of the inspection.

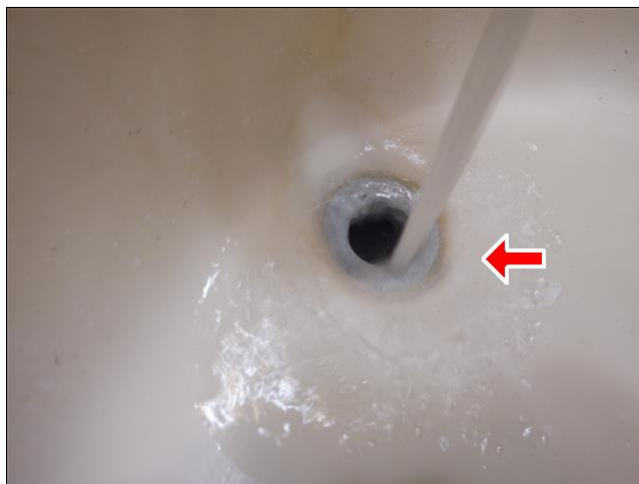
Hallway Bathroom

- ☒ ◆ Drain stop(s) that were not functioning properly were found in the following locations: master bathroom and hall bathroom. Have a qualified technician make repairs as needed.

- 16 Drain stop(s) that were not functioning properly were found in the following locations: master bathroom and hall bathroom. Have a qualified technician make repairs as needed.

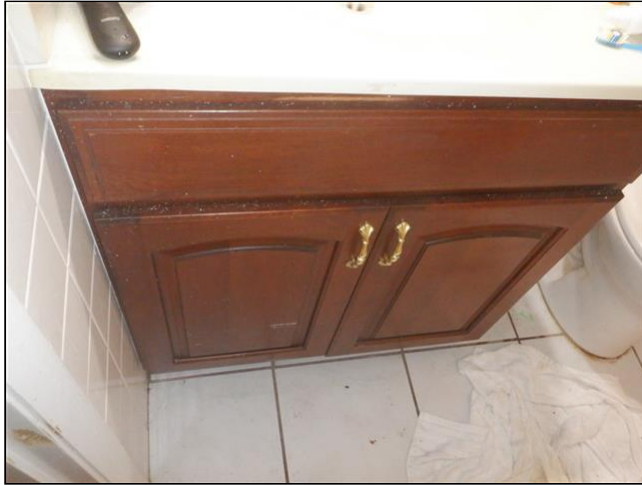
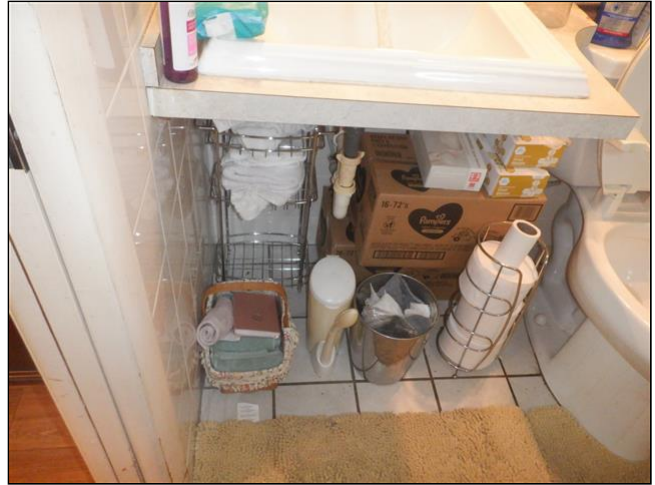
Hallway Bathroom

- ◆ The counter tops and cabinets were in acceptable condition on the day of the inspection.

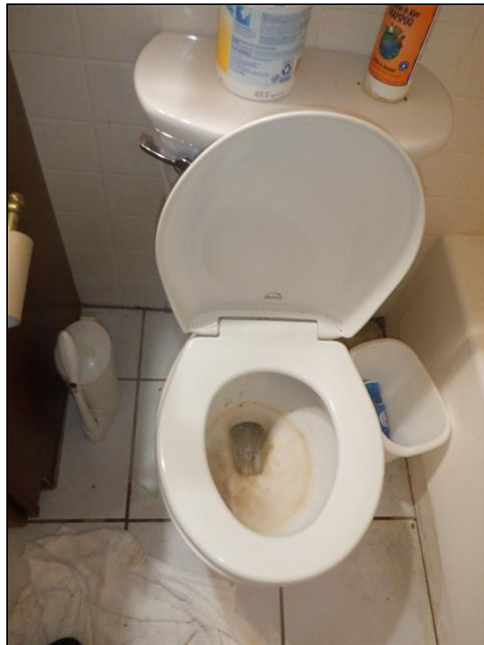
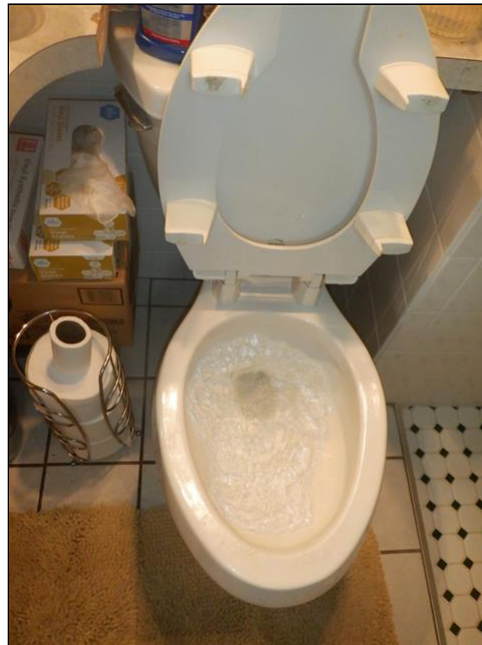
Hallway Bathroom

- ◆ The toilets flushed and were not loose on the day of the inspection.

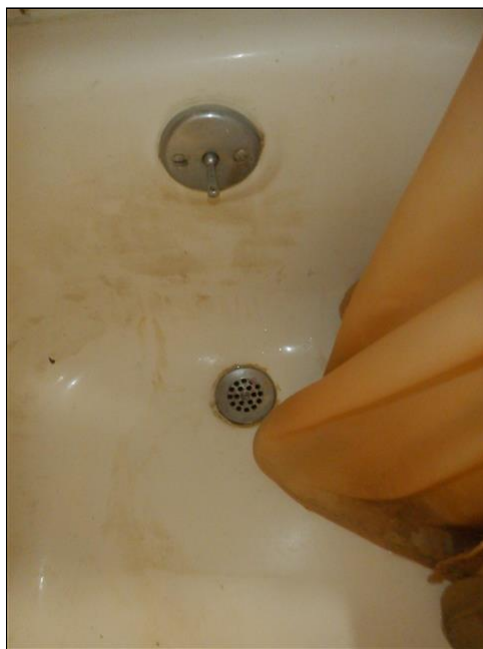
Hallway Bathroom

- ❌ ♦ One or more of the mechanical drain stops at the bathtubs is not functional. This is a common condition with older tubs and repair parts may not be readily available.

- 14 One or more of the mechanical drain stops at the bathtubs is not functional. This is a common condition with older tubs and repair parts may not be readily available.
- 15 A valve stem is leaking at the faucet in the hall bathroom. All valve stem leaks should be repaired.

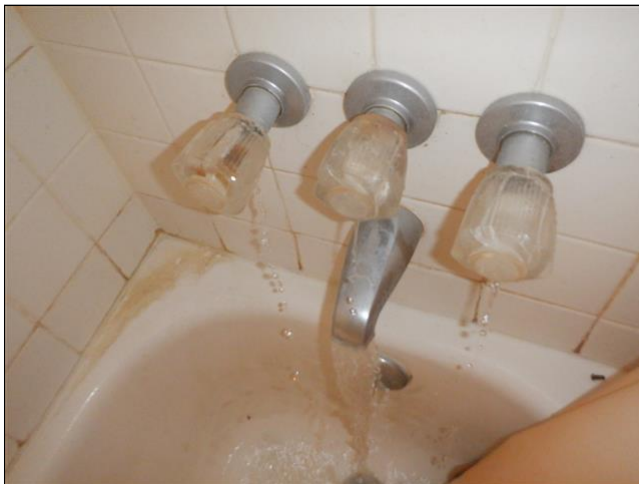
Hallway Bathroom

- ❌ ♦ A valve stem is leaking at the faucet in the hall bathroom. All valve stem leaks should be repaired.

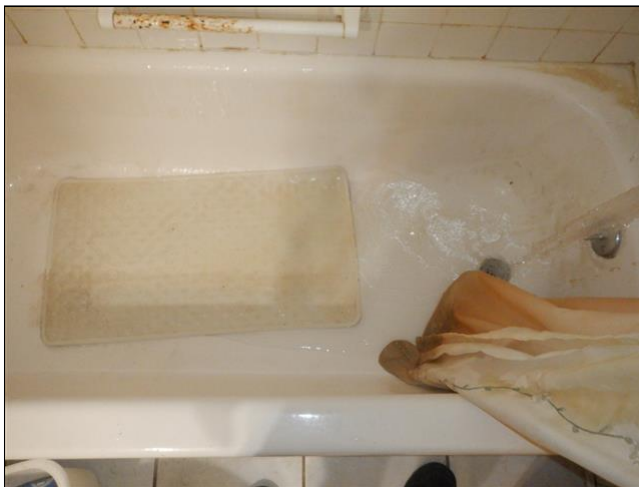
Hallway Bathroom

- ◆ The surface finish of the bathtub in the hall bathroom is marred. Sometimes, such finish damage can be patched. There are companies that specialize in the refinishing of bathroom surfaces with epoxy coatings or fiberglass repairs. Repairs may not be as durable as the original finish, but if done properly they can extend the service life of the bathtub. Consideration should be given to this type of repair as an alternative to the more expensive option of replacing the bathroom fixture.

- 17 The surface finish of the bathtub in the hall bathroom is marred. Sometimes, such finish damage can be patched. There are companies that specialize in the refinishing of bathroom surfaces with epoxy coatings or fiberglass repairs. Repairs may not be as durable as the original finish, but if done properly they can extend the service life of the bathtub. Consideration should be given to this type of repair as an alternative to the more expensive option of replacing the bathroom fixture.

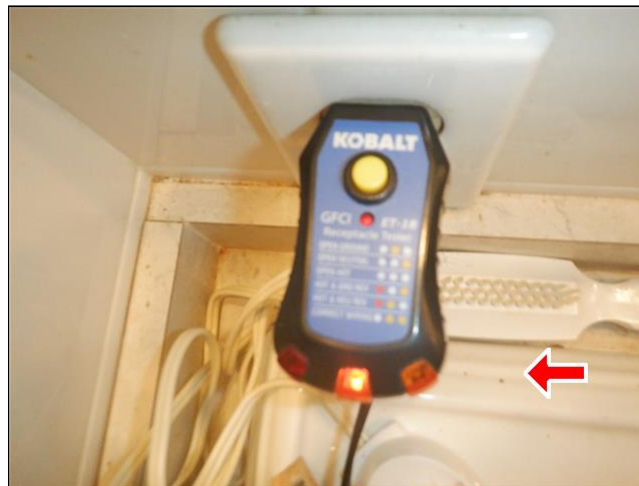
Master Bathroom

- ❌ ◆ There is an ungrounded receptacle(s) in the master bath and hall bath. Three-pronged receptacles should be grounded. The ground is a safety feature. A qualified electrician should make repairs or modifications as necessary to any ungrounded receptacle.

- 16 There is an ungrounded receptacle(s) in the master bath and hall bath. Three-pronged receptacles should be grounded. The ground is a safety feature. A qualified electrician should make repairs or modifications as necessary to any ungrounded receptacle.

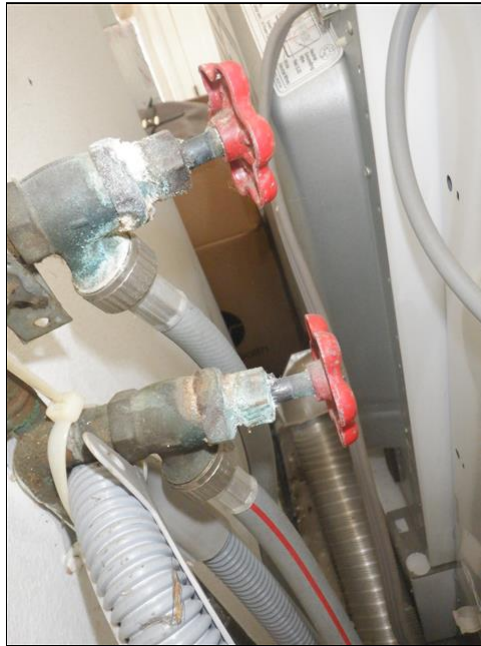
Laundry Room

- ◆ The plumbing connections for the washing machine were not leaking on the day of the inspection.

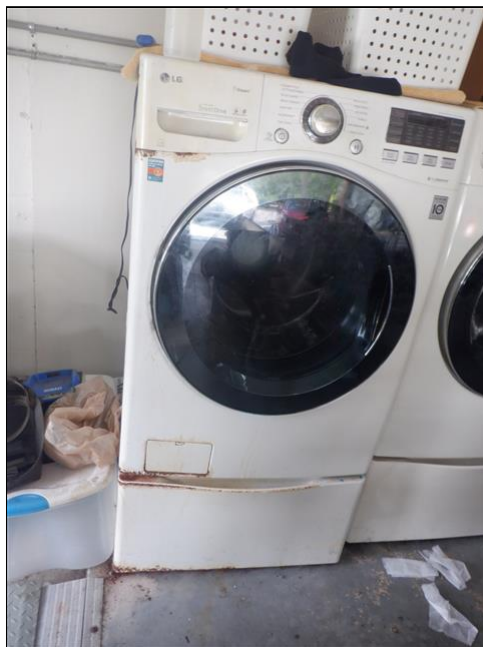
Laundry Room

♦ Although the clothes dryer is functional, it is older. Budget to replace.

- 19 Although the clothes dryer is functional, it is older. Budget to replace.

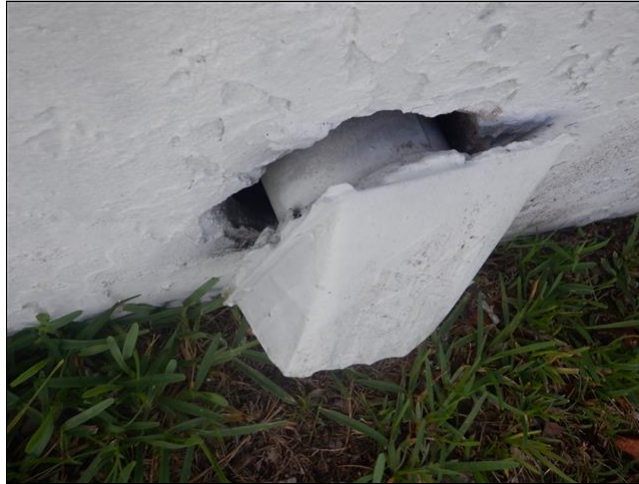
Laundry Room

♦ The clothes dryer vent is not caulked at the exterior wall. Clothes dryer vents that are not vented properly can cause moisture/lint problems and could be a fire hazard. A qualified technician should repair or replace as needed.

- 17 The clothes dryer vent is not caulked at the exterior wall. Clothes dryer vents that are not vented properly can cause moisture/lint problems and could be a fire hazard. A qualified technician should repair or replace as needed.

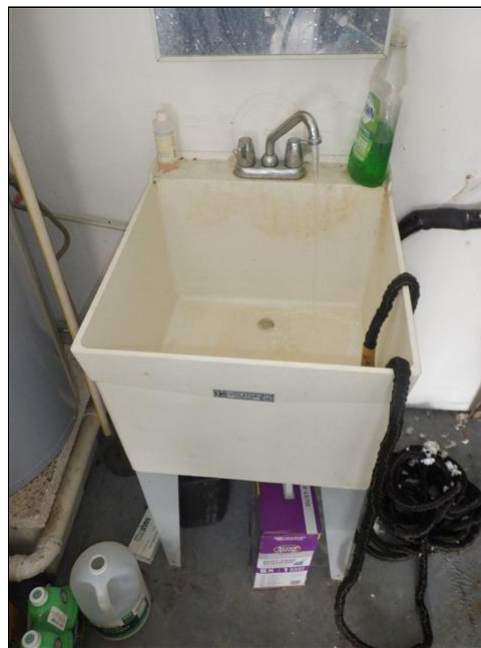
Laundry Tub

- ◆ The laundry tub reported on here is located in the garage.

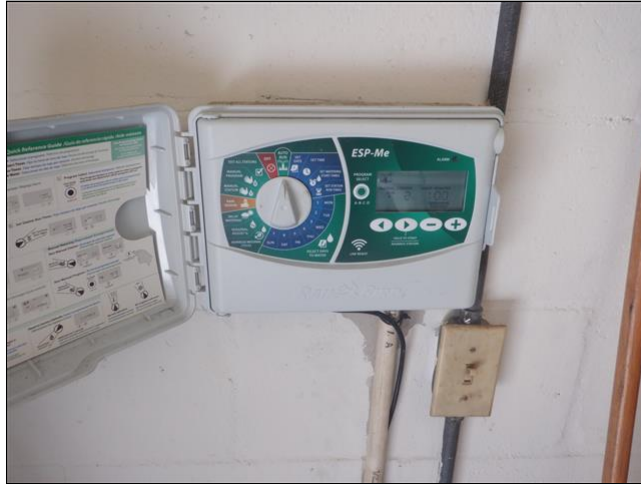
Control Box

- ❌ ◆ The yard irrigation system did not respond to normal operator controls. Repairs are needed. A qualified technician should inspect further and repair as needed.

- 18 The yard irrigation system did not respond to normal operator controls. Repairs are needed. A qualified technician should inspect further and repair as needed.
