BPG Inspection, LLC

**Ashwood Drive
Tampa FL 33624**

Client(s): Jenifer
Inspection Date: 9/8/2022
Inspector: David Batha , HI8000 (FL)

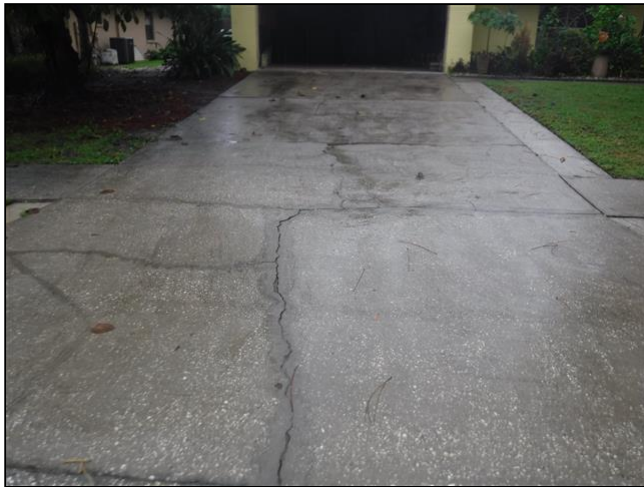
Driveway

- ◆ Except for typical hairline cracks, the driveway, walkways and patio(s) showed no visible signs of any deficiencies on the day of the inspection.

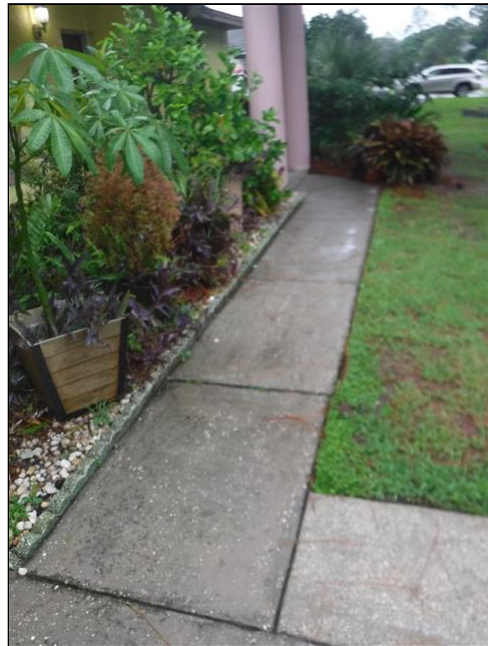
Front Walk

- ◆ There were common cracks and typical settlement in the concrete flat work observed on the property. All concrete flat work is intact and functional.

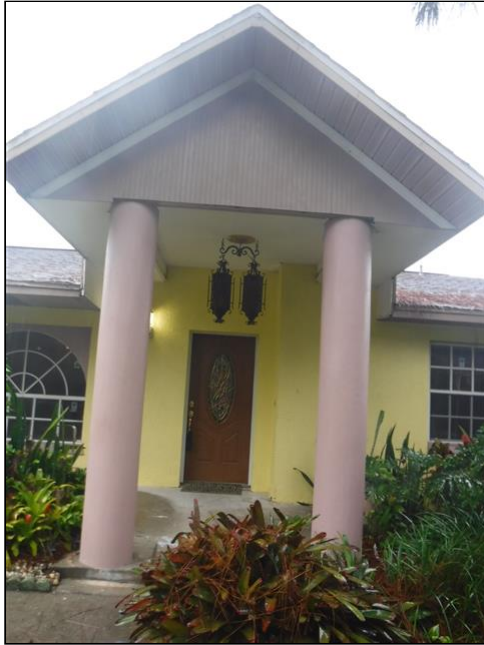
Front Porch

- ◆ The porch, patio and balcony (if applicable) structures showed no signs of any deficiencies at the time of inspection.

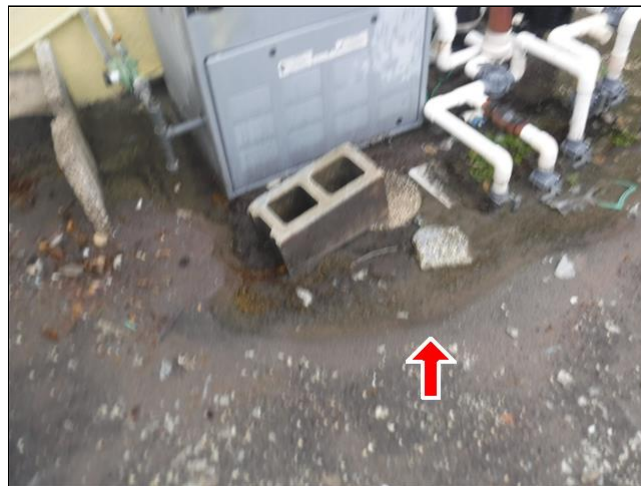
Building exterior

- ❌ ◆ Based on a visual inspection of the surface drainage, and evidence of water accumulation near the south elevation, there is either not a proper drainage system installed, or the existing system is inadequate. A qualified technician should make repairs or modifications as necessary.

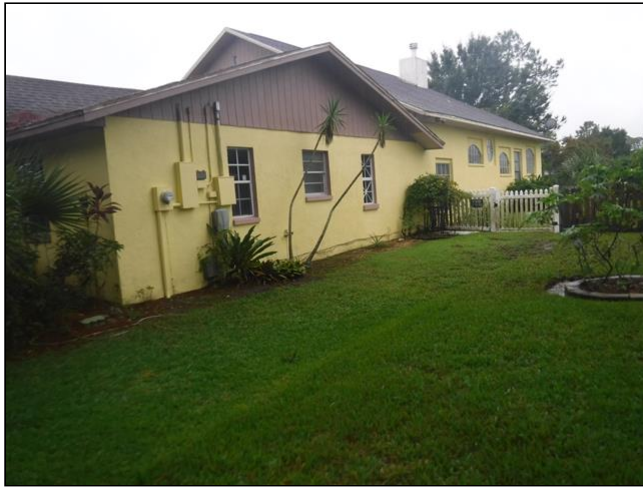
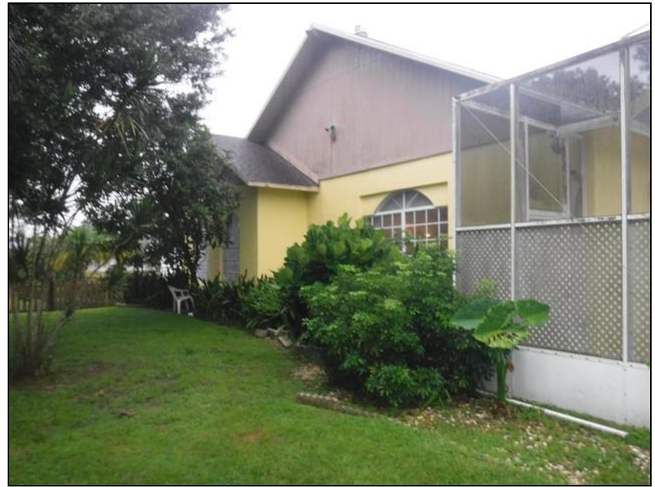
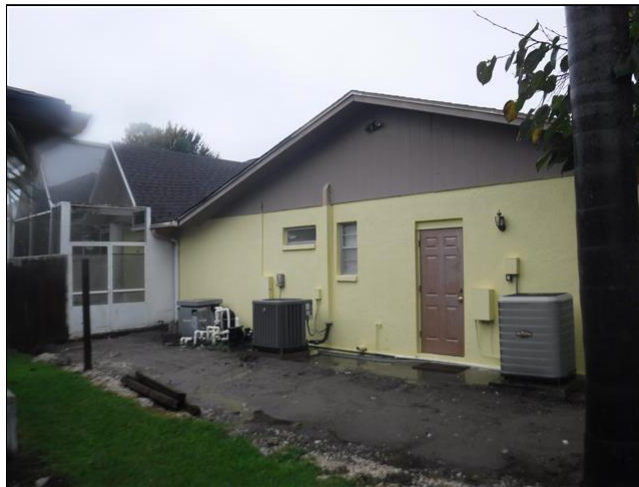
Building exterior

- ✔ ◆ Typical cracks were observed. Unless the cracks exceed one sixteenth of an inch in width, repair is not necessary. We recommend that you monitor all cracks and repair when required.
- ✘ ◆ Finishes at the wood or composite siding are failing. Refinishing is recommended.

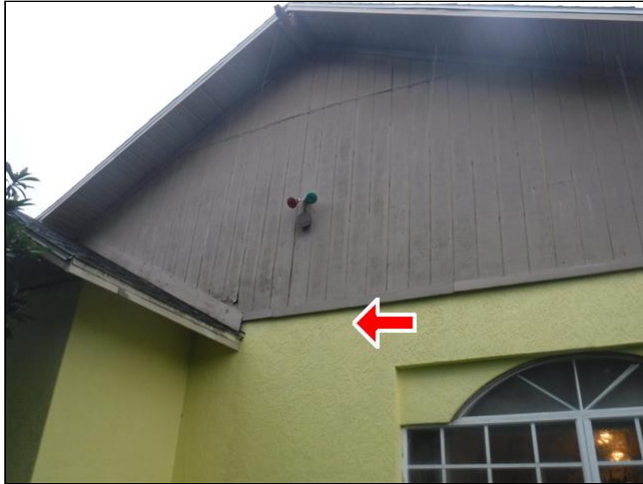
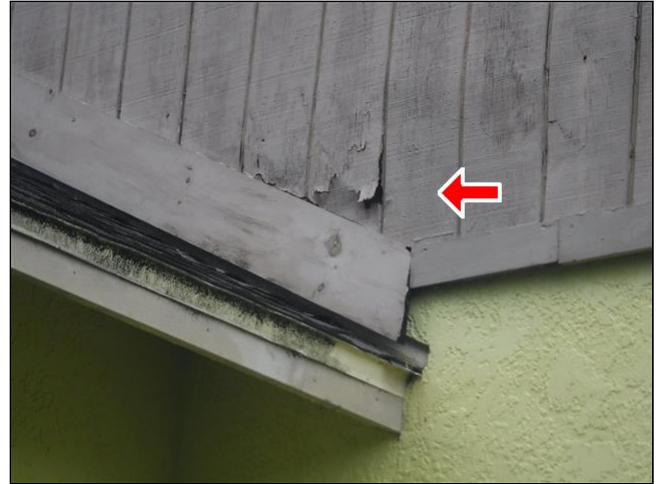
Building exterior

- ✘ ◆ The wood or composite siding is water damaged and deteriorated at the at the bottom edge in several places. Some repair or replacement by a qualified person is recommended.

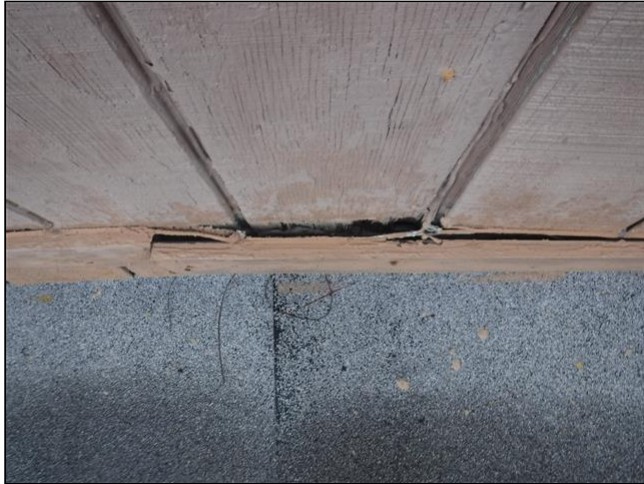
Building exterior

- ❌ ◆ Pieces of the wood siding are loose at the exterior. Loose siding should be re-nailed according to the manufacturer's specifications. Doing the work properly may require further caulking, patching and painting.

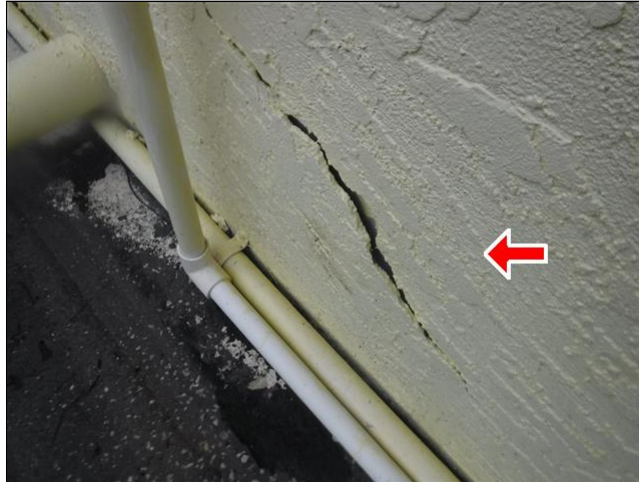
Building exterior

❌ ♦ Damage noted at the stucco cladding on the south elevation. A qualified person should make repairs.

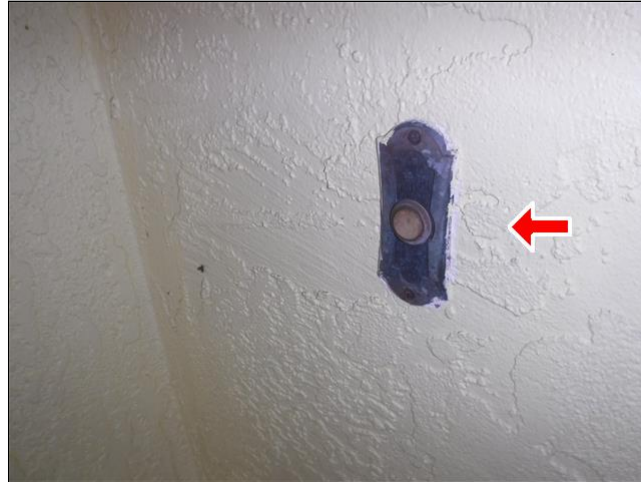
Doorbell

- ☒ ◆ The doorbell is not functional. The doorbell should be repaired or replaced. Check the inexpensive exterior button first for function, then the interior bell or transformer.

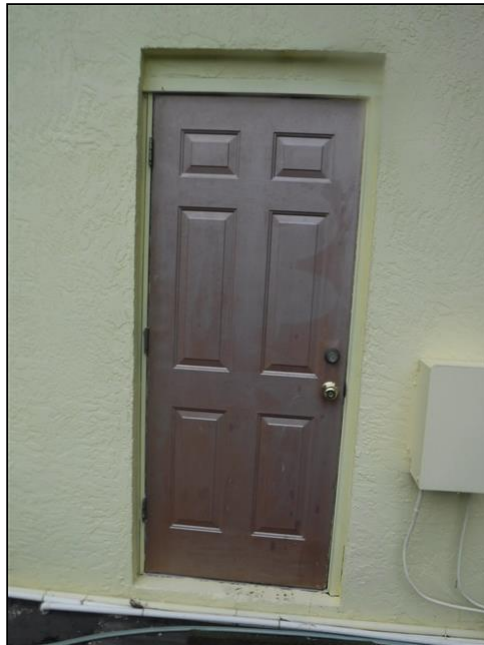
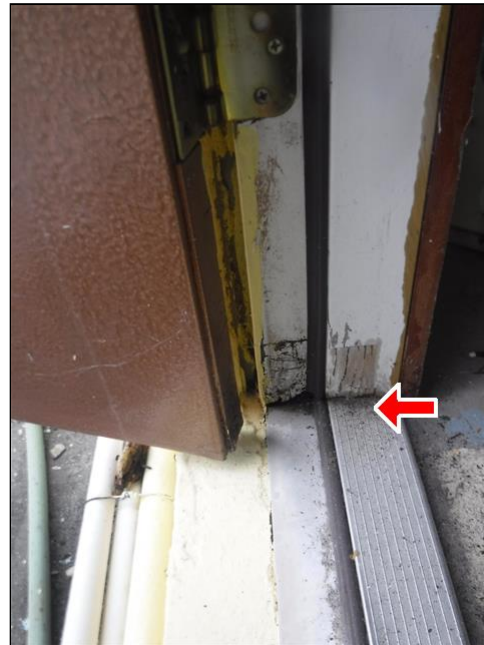
Garage Door

- ❌ ♦ The garage service door jamb is deteriorated. The damaged elements of the jamb should be replaced.

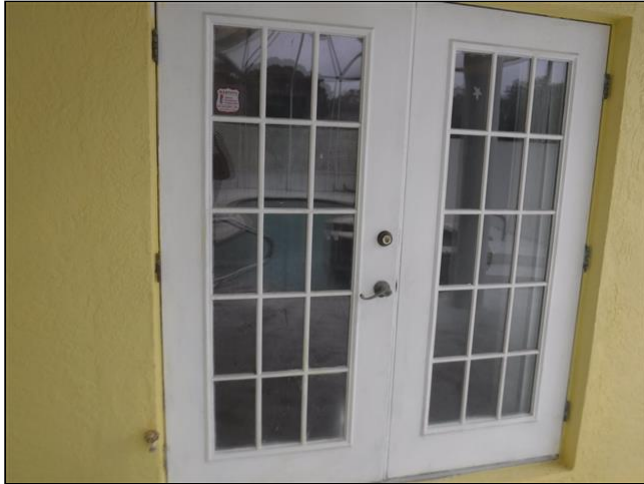
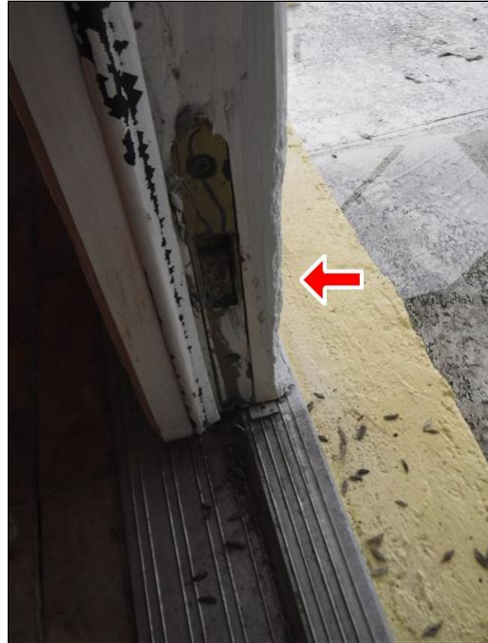
Building exterior

- ❌ ♦ One or more of the deadbolts on the exterior doors requires a key to operate from both sides. This is a safety / fire concern because a key must be in the lock or close by to facilitate egress. We recommend converting to a lever action bolt on the interior side of the door.
- ❌ ♦ The back door lock is inoperable. The lock should be replaced.

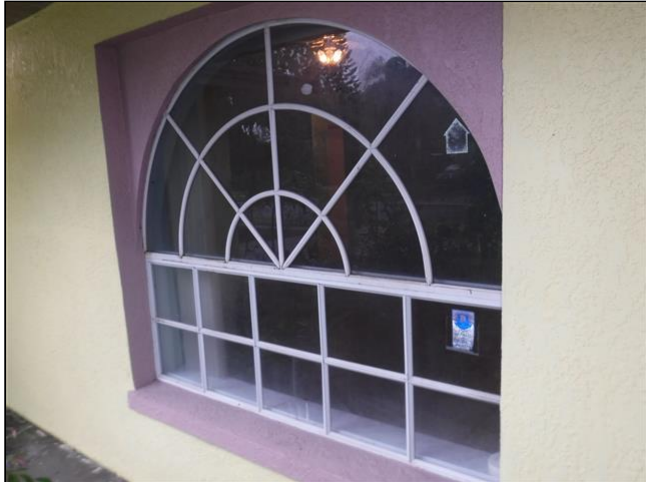
Building exterior

- ❌ ♦ One or more window panes are cracked or broken. A qualified glazier should replace all broken glass.

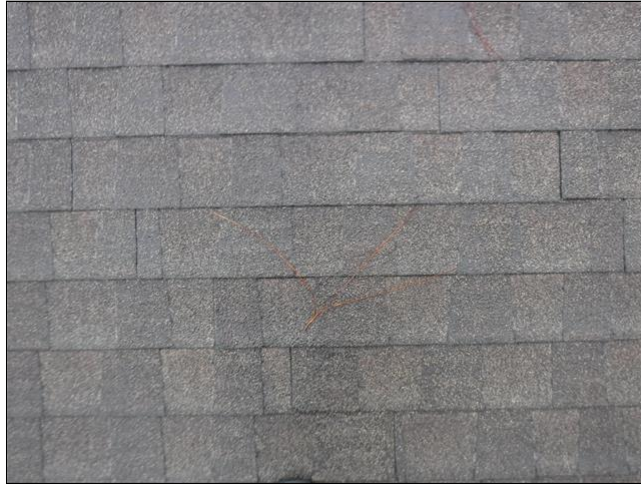
View of Roof While Walked

Portions of the surface granulation have washed away and minor surface cracks have developed. These are normal signs of aging and no action is needed at this time. Loss of granules is a primary indicator of advanced age and deterioration. Budget for eventual replacement of the roof covering.

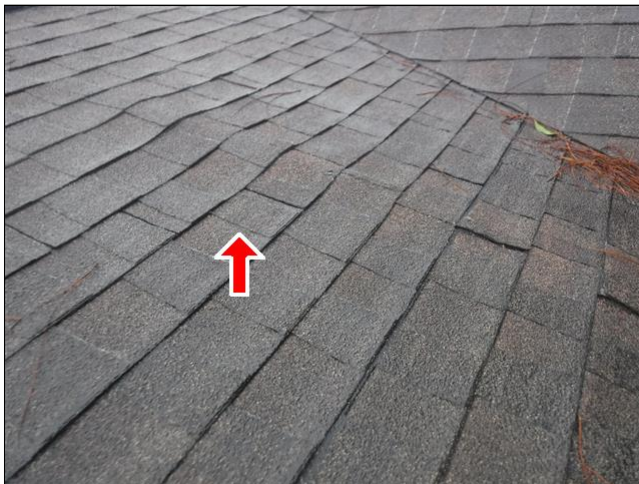
View of Roof While Walked

- ❌ ◆ Active leaks were observed during inspection of the roof cover(s). Details as to the areas or locations affected will be described in other sections of the report such as ATTIC.
- ❌ ◆ The Entire roof is near or at the end of its expected service life. It is recommended that you consult a licensed Roofing contractor to determine the remaining useful life, if any and replacement cost.
- ❌ ◆ Shingles at the front of home are loose. This may be a result of wind and weather, or it may indicate improper installation. A qualified technician could make repairs or modifications as necessary.

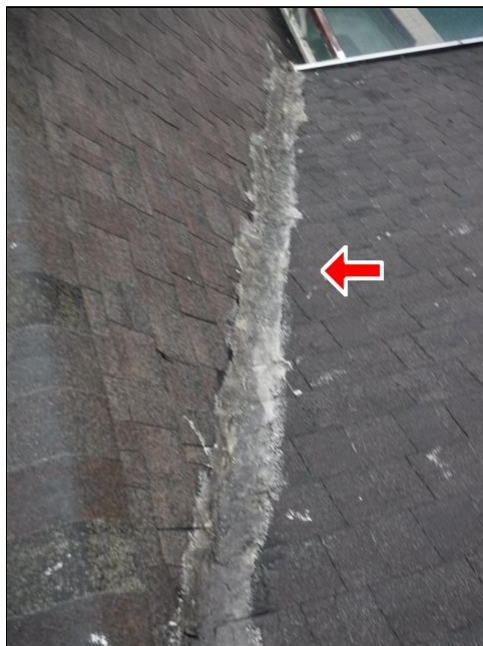
Valley

- ◆ All visible flashing materials showed no signs of any deficiencies on the day of the inspection.
- ☒ ◆ Roof mastic flashing observed at the valley, amateurish repair.

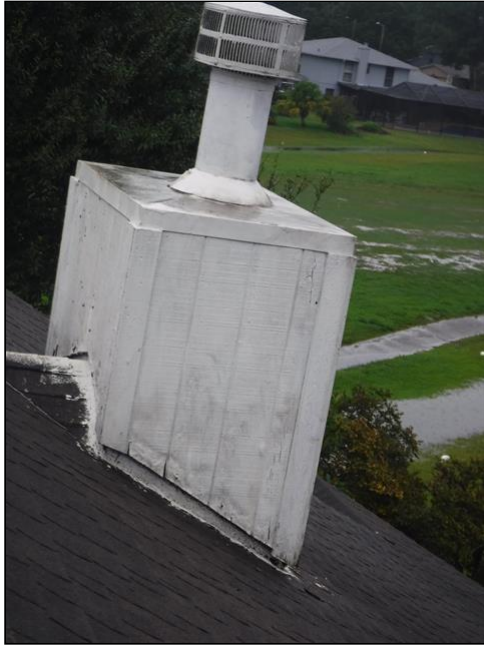
Chimney

- ☒ ◆ The composite wood siding at the chimney has one or more of the following conditions requiring repairs or replacement by a qualified person. Water damaged siding / deteriorated siding / loose siding / nail pops / loose wood trim.

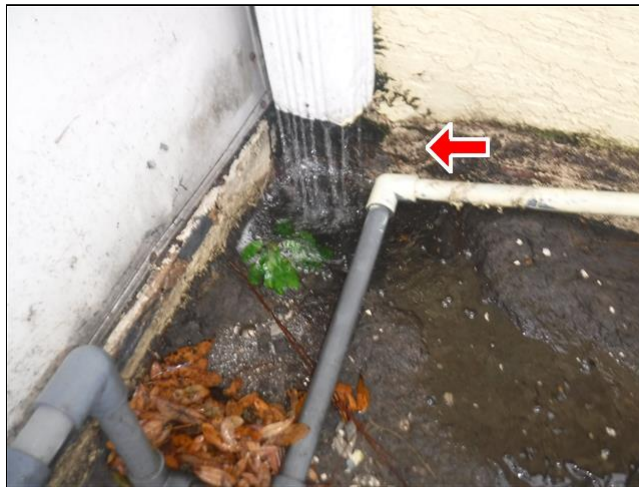
Downspout

- ◆ Wherever possible, downspouts should be extended to a length of at least 6' from the foundation

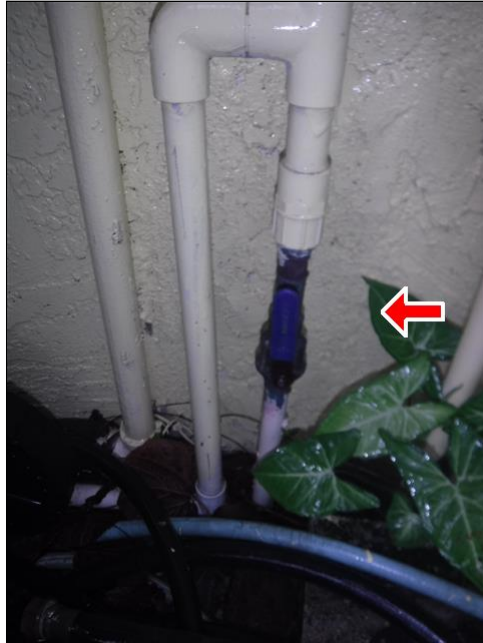
Main Water Shut Off Valve

- ◆ No defects were observed concerning the main shut off valve during the inspection.

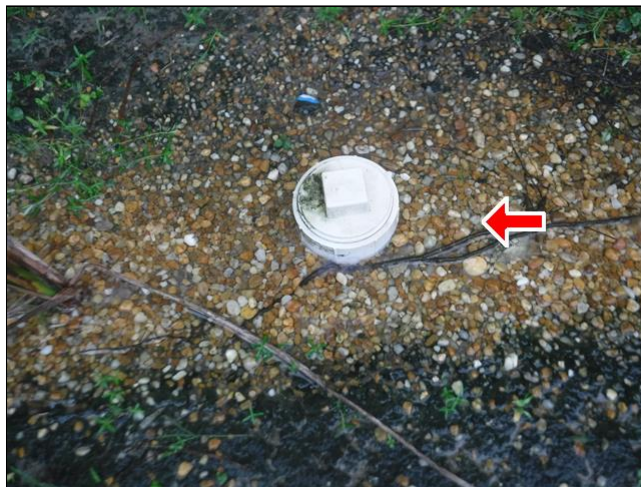
Main Plumbing Clean Outs

- ◆ The drain / waste / vent piping as described in the Styles & Material section showed no defects during the inspection. NOTE: This statement applies to the visible areas only.
- ◆ The main clean outs were located at the (north) elevation.

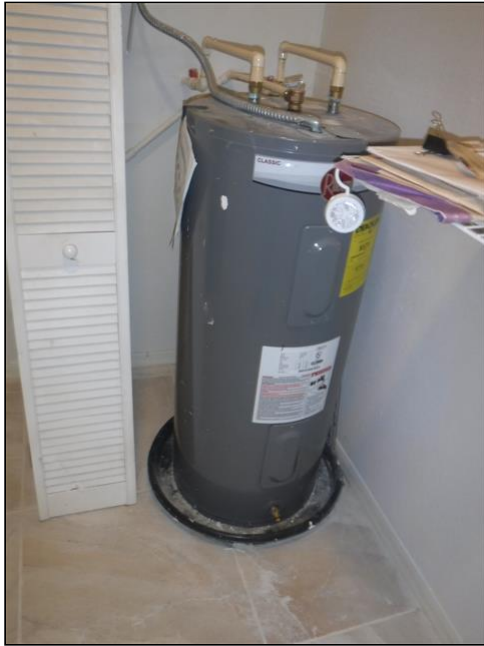
Water heater

- ◆ The design of electric water heaters does not lend itself to internal inspection. We cannot estimate its life expectancy. The water heater was intact and functional at time of inspection. NOTE: The normal useful life of most water heating systems is 8 to 10 years.

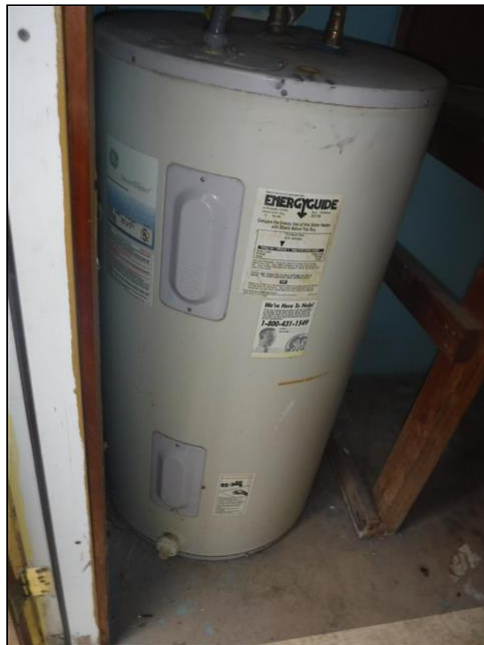
Water heater

- ☒ ◆ This water heater is beyond its anticipated service life. Although it is still operating, you should expect to replace it in the near future.

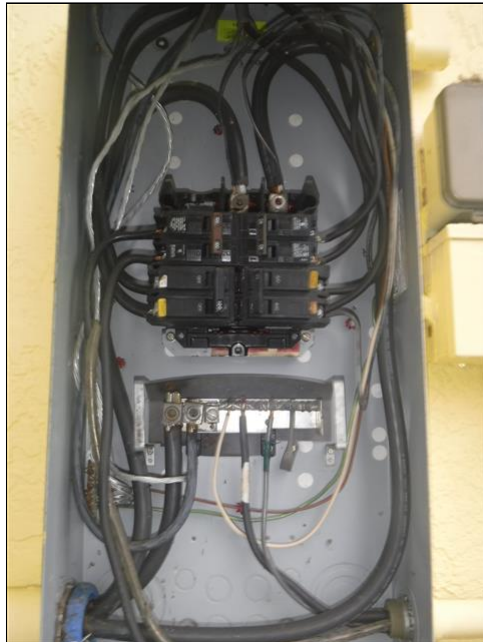
Main Disconnect

- ✘ ◆ At least one circuit breaker in main service disconnect are of a different brand than panel manufacturer. The manufacturer requires that in order for the panel to be safe, only their brand is allowed to be used inside the panel. Even though these circuit breakers are all "UL approved," they are not approved to be used in panels of different manufacturers unless so indicated on the panel label.

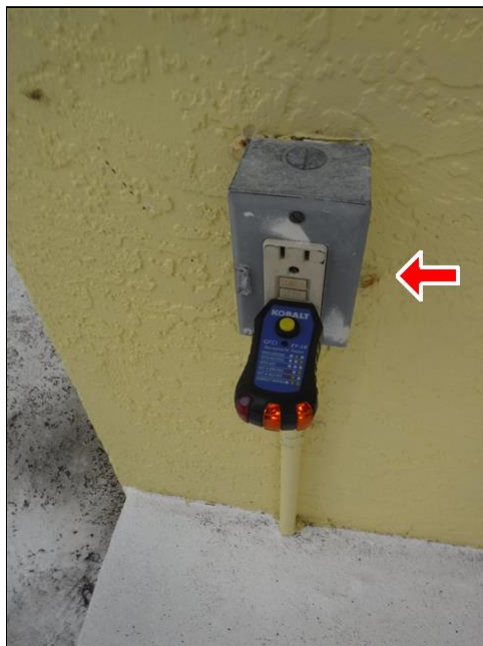
Building exterior

- ❌ ♦ The weather resistant outlet cover at the rear of the home is damaged or missing, repair or replace as needed.

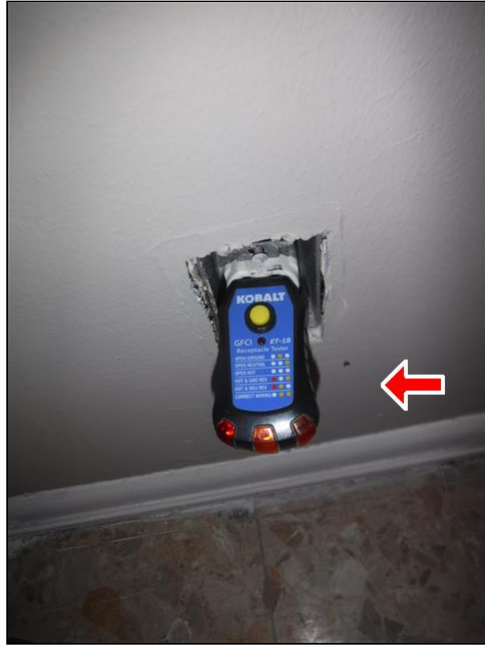
Addition

- ❌ ♦ There is an outlet(s) that is not energized in the bedroom in the addition. It does not appear to be controlled by a switch. We DID NOT necessarily list all locations. Have a qualified electrician make repairs.

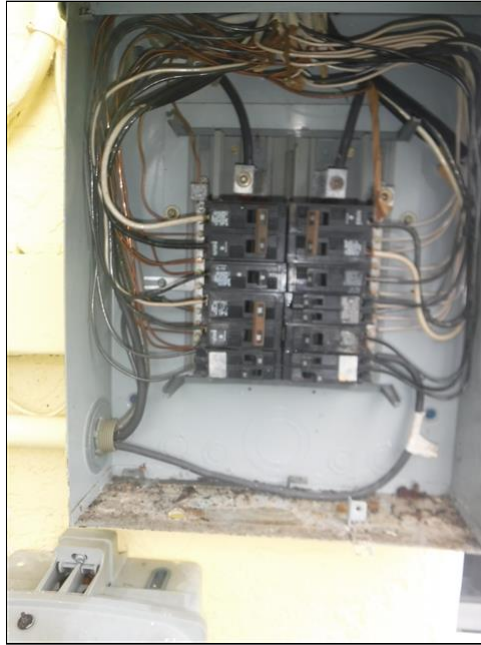
Sub Panel

- ◆ The sub panel(s) showed no defects on the day of the inspection.

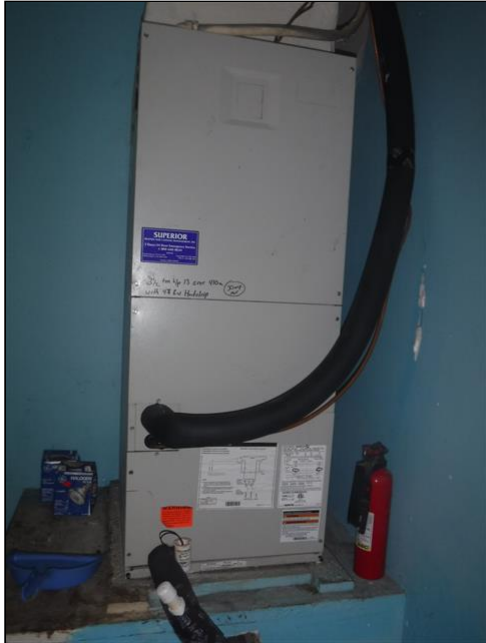
Air Handler

- ◆ Air handler unit #1 is located in the garage. The air handler is approximately 10 years old.

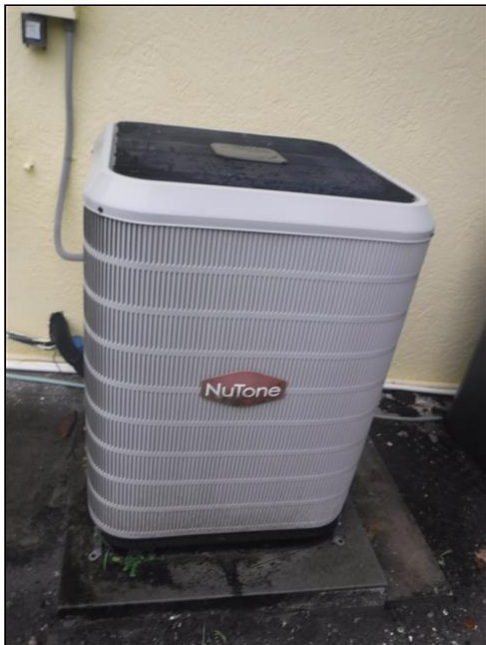
Heat Pump

- ◆ Air Conditioning Unit #1 is located at the left side. The capacity of the unit is approximately three and one half tons. The age of the unit is 10 years old as determined by the data plate.

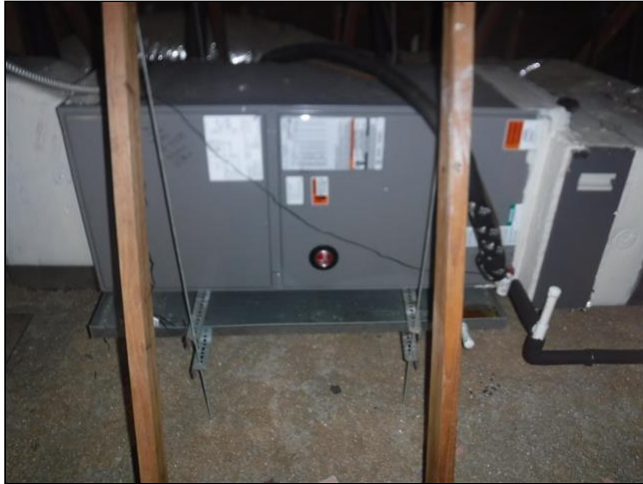
Attic Mounted Air Handler

- ◆ Air handler unit #2 is located in the attic. The air handler is approximately 3 years old.

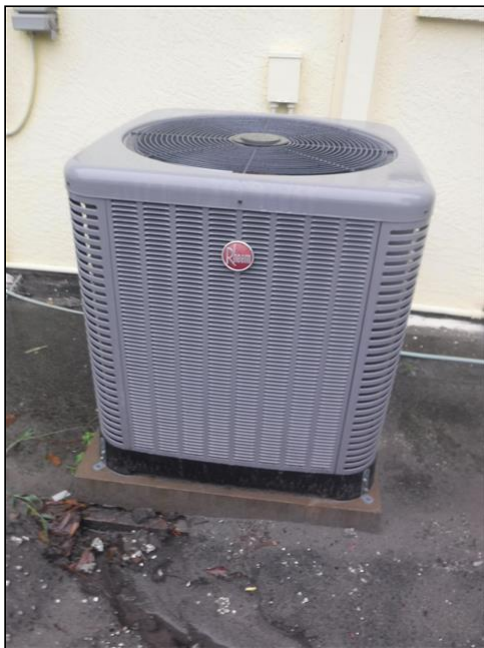
Condensing Unit

- ◆ Air Conditioning Unit #2 is located at the left side. The capacity of the unit is approximately three and one half tons. The age of the unit is 3 years old as determined by the data plate.

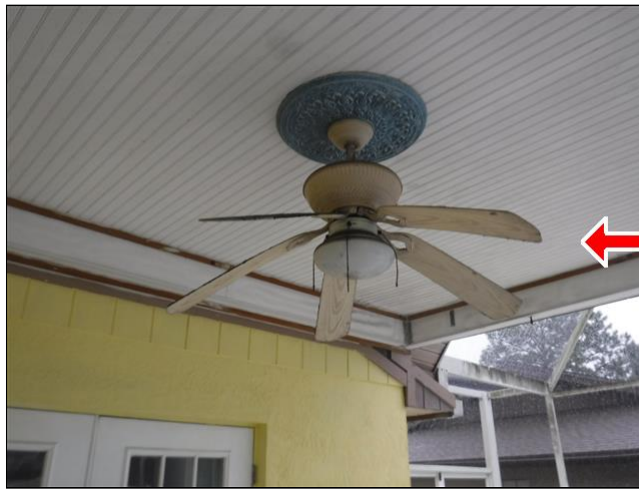
Back Patio

- ◆ A ceiling fan is not functional in the back patio. A qualified technician could evaluate the fan and determine what corrective action is necessary.

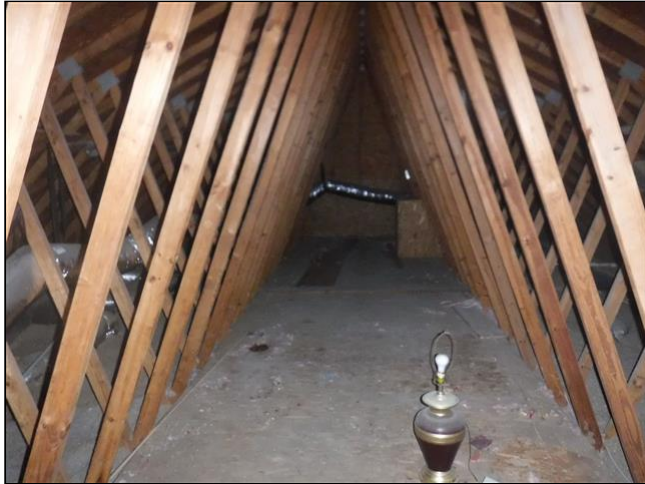
Photos of Attic Space

- ⊗ There are water stains visible at more than one of the top cords of the roof trusses. These stains are an indication that the felt paper underlayment for the tile roofing is breaking down and needs replacement. A licensed roofing contractor should review the underlayment for replacement costs per the current installation standards for tile roofing.
- ⏏ There is evidence of present leaks in the attic. Water stains are present at areas of the Sheathing. Leaks may still exist in one or more areas, We are unable to confirm if proper repairs have or have not been completed. A qualified roofing contractor should evaluate the roof and make repairs or modifications as necessary.

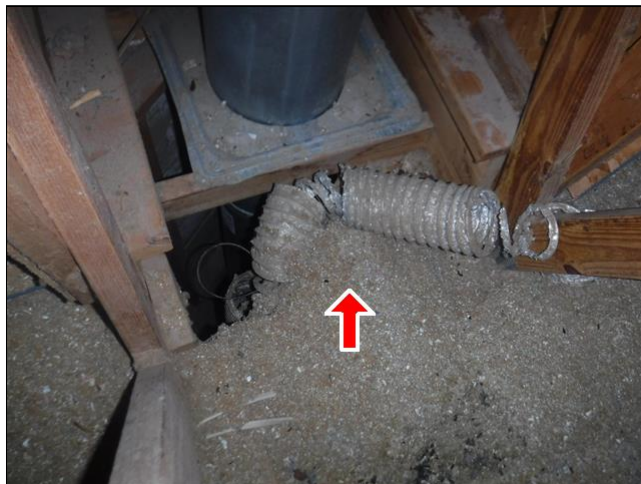
Photos of Attic Space

- ❌ ♦ The duct(s) from the master bathroom exhaust fan terminates in the attic, rather than on the exterior of the building. This allows excessive moisture to be vented into the attic, which can result in damage to wood elements of the roof structure. Have a qualified technician run the duct to the exterior of the building.

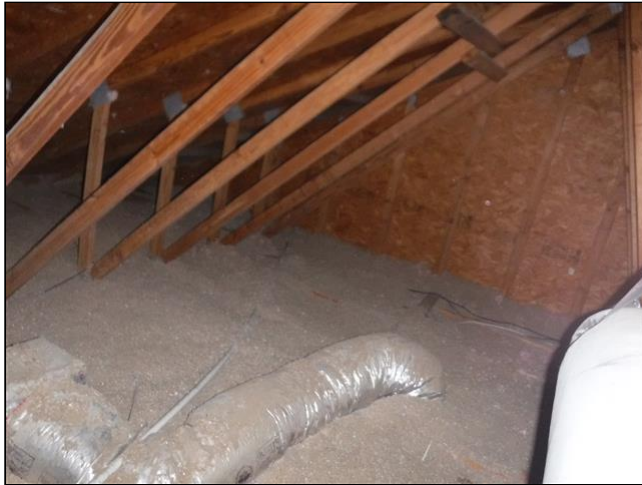
Photos of Attic Space

- ◆ The insulation above the living spaces in this building is inadequate by present building standards. The U.S. Department of Energy recommends (R-30) value of insulation in attics. Adding insulation usually is a cost-effective activity, the cost of which generally can be recovered in a few years. Having an insulation contractor add insulation to increase the thermal resistance of this area would be beneficial in reducing heating and cooling costs.

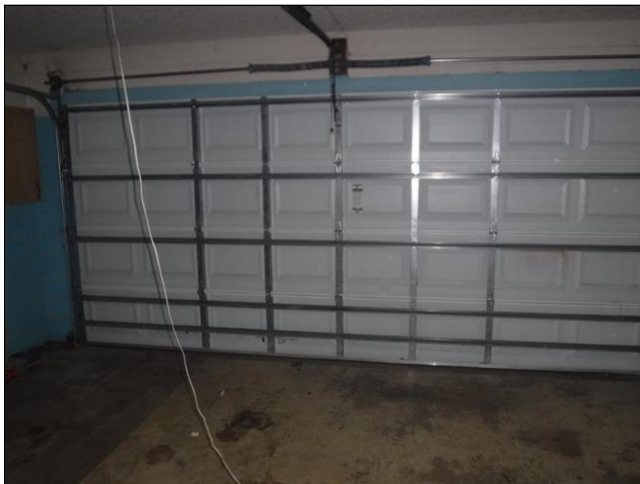
Garage Door

- ✗ ◆ The garage door opens but cannot be closed without holding the control button down for the complete cycle. This indicates a problem with one or both of the safety reverse features. A qualified person should evaluate the opener and make repairs.

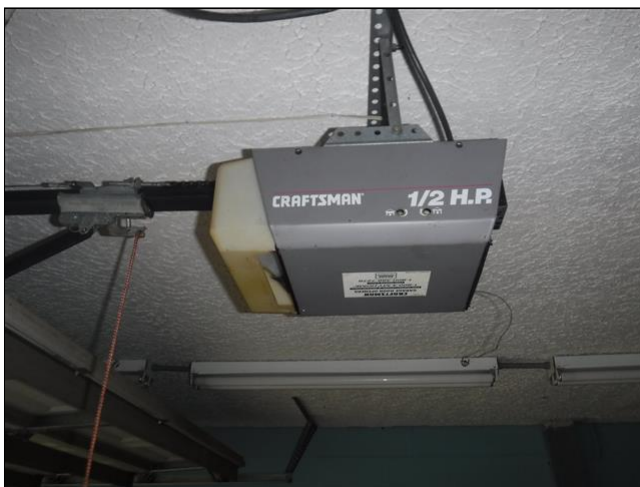
Garage Door Opener

- ❌ ♦ The garage door opener appears to be original to the home and will have a limited remaining useful life. Budget for future replacement.

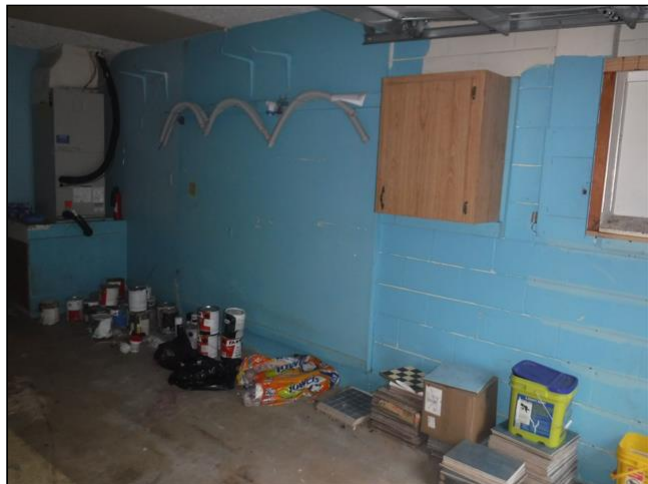
Garage Interior

- ❌ ♦ There is damage to the drywall in the garage. This is the ceiling this is part of the homes fire wall assembly. Repairs are needed.

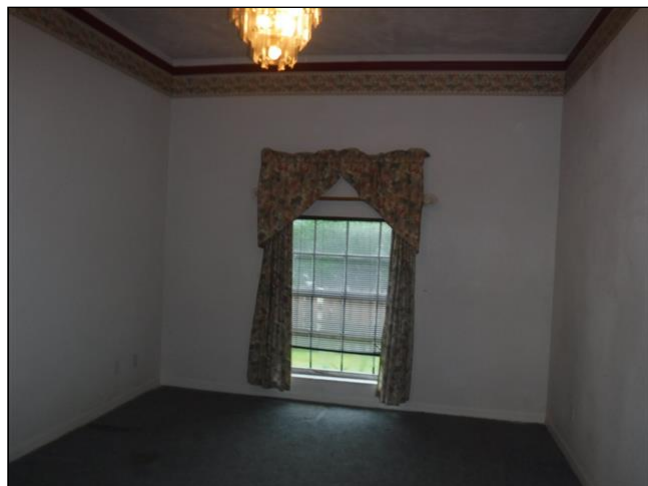
Building Interior Rooms

- ❌ ♦ There is evidence of previous patching and/or repairs to the finished surfaces in the master bedroom. Repairs are needed.

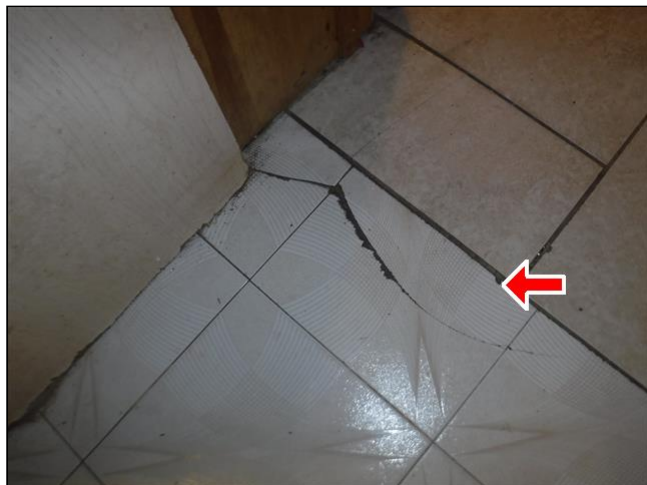
Building Interior Rooms

- ☒ ♦ One or more floor tiles are cracked, missing and/or damaged. Damaged tiles should be replaced as necessary. A qualified technician could do the work.

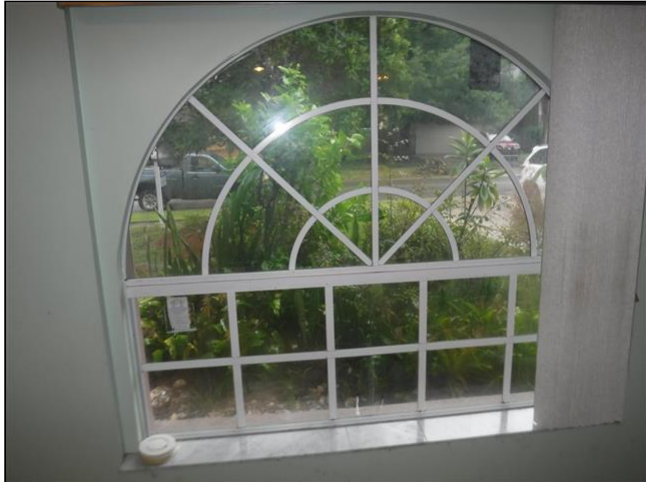
Building Interior Rooms

- ☒ ♦ A window pane(s) is cracked in several rooms. This can be a safety hazard. All cracked glass should be replaced by a qualified glazier. If the glazing is dual pane, replacement may be required. Consult a qualified person for repair / replacement.

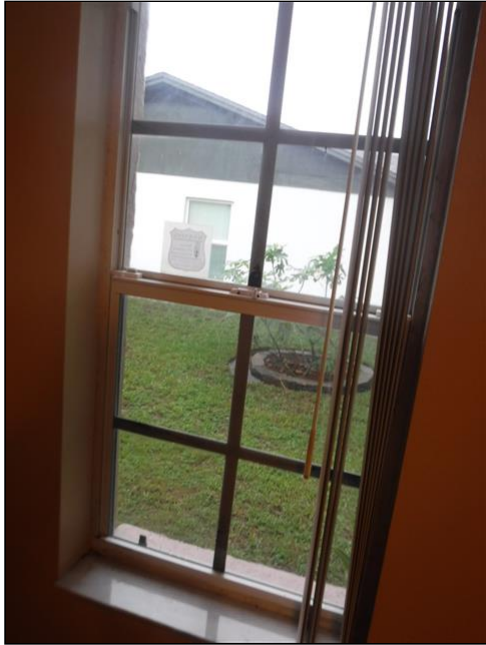
Building Interior Rooms

❌ ♦ There is a inoperable latch at a window in one or more rooms Replace affected latches as needed.

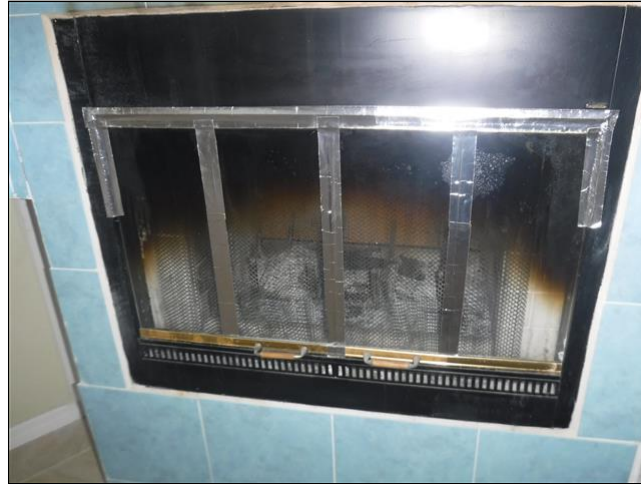
Fireplace

- ☒ ◆ The glass doors to the fireplace are damaged. Repair or replacement of the glass doors is recommended.

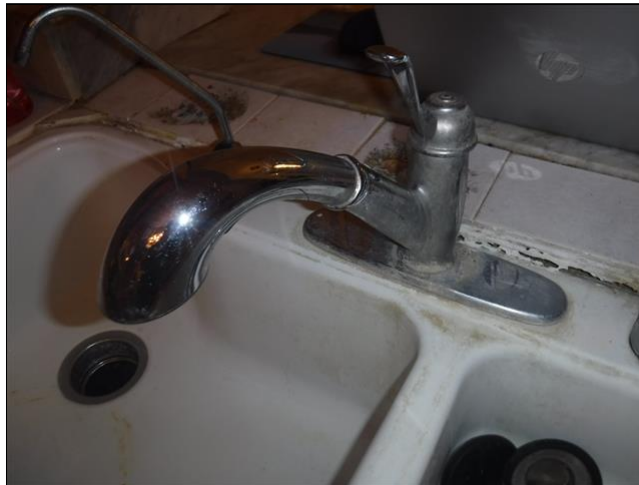
Kitchen Area

- ❌ ◆ The kitchen sink faucet frozen and in need of repair.

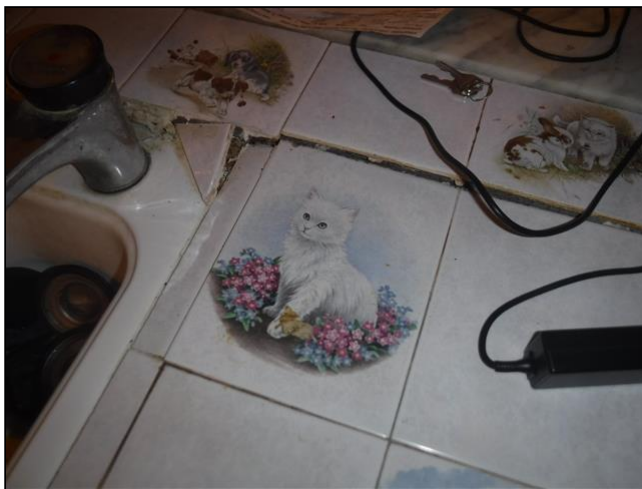
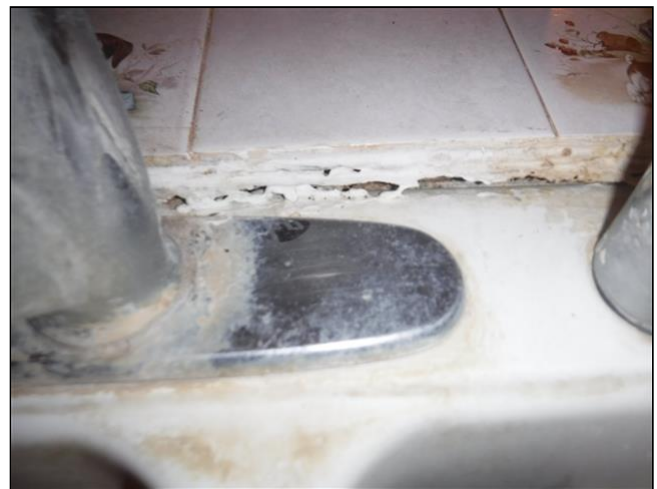
Kitchen Area

- ❌ ◆ The Cabinet is deteriorated in the area under the sink. Water leakage appears to have promoted decay. Cracked, deteriorated or damaged wood should be replaced.
- ⬆️ ◆ The countertop has cracked and/or chipped tiles. The tiles should be replaced.

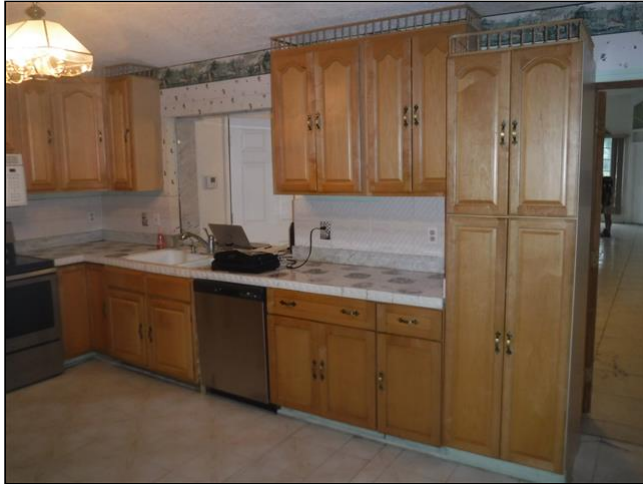
Kitchen Area

- ⬆️ ◆ The countertop and cabinets are deteriorated. This affects its appearance, and may limit its remaining useful life.

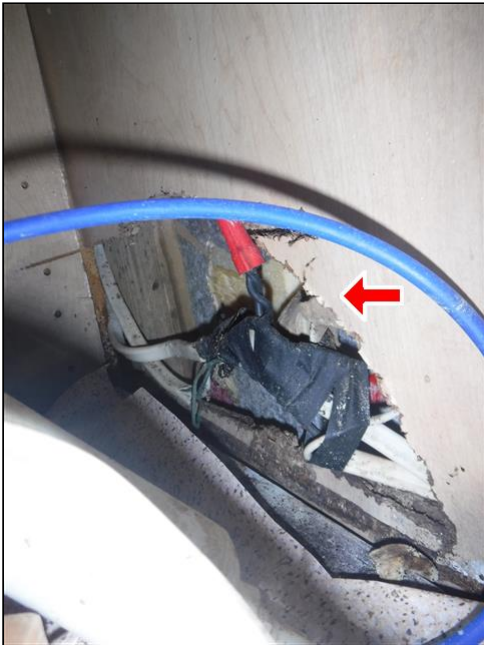
Kitchen Area

- ❌ ♦ Wire connections are exposed at the disposal. No bare, exposed metal wiring should be visible under the sink, nor wire splices, any of which could be a shock hazard. Have an electrician make repairs.

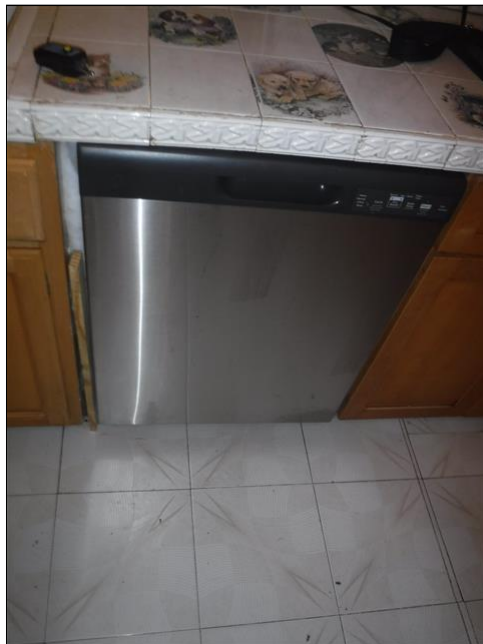
Kitchen Area

- ☑ ♦ The dishwasher was tested using normal operating controls and it functioned. However, it is near the end of its useful life. Budget for future its replacement.

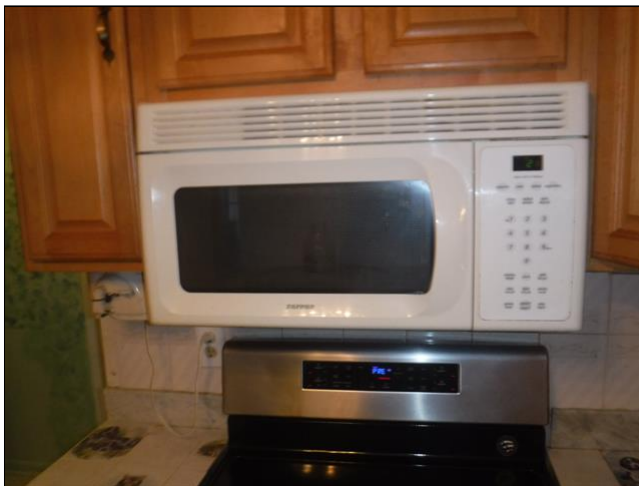
Kitchen Area

♦ The microwave was tested using normal operating controls. It functioned normally. However, it is near the end of its useful life. Budget for future replacement.

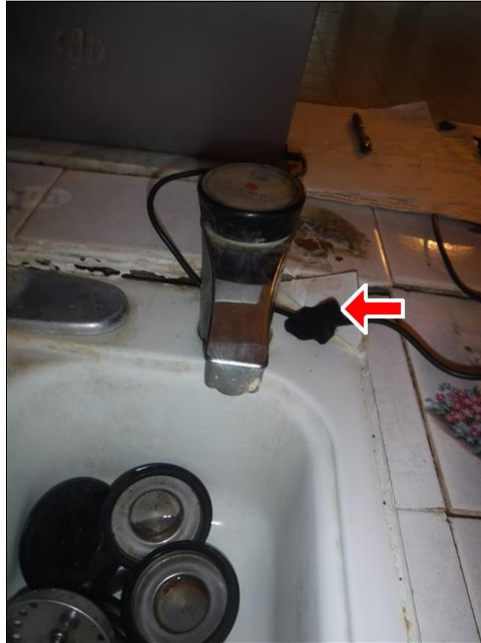
Kitchen Area

♦ The instant hot faucet did not operate through the control switch. This appliance is old and in replacement condition.

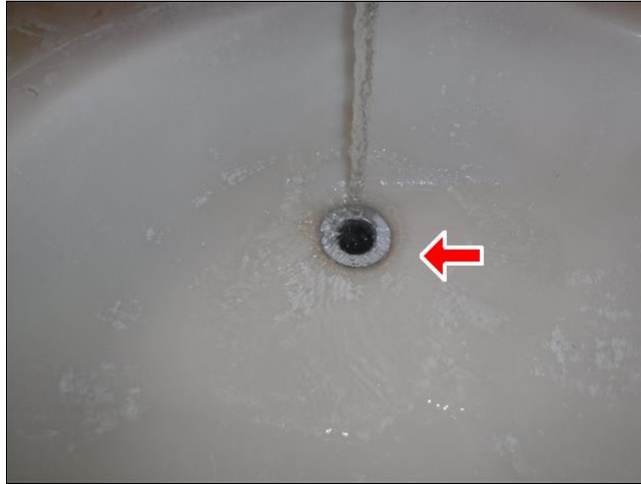
Master Bathroom

- ◆ Drain stop(s) that were not functioning properly were found in the following locations: master bathroom. Have a qualified technician make repairs as needed.

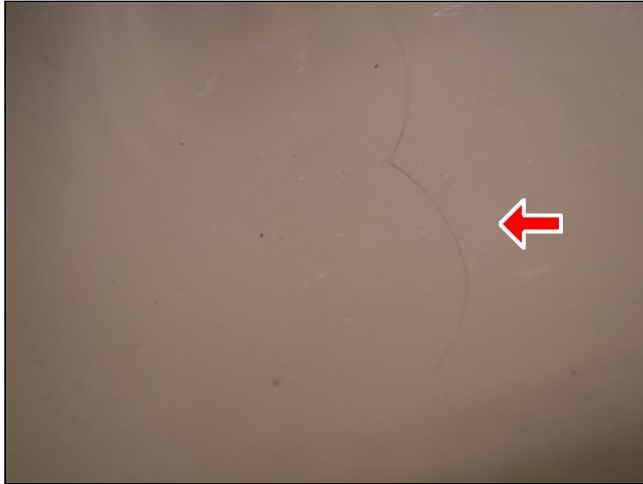
Hallway Bathroom

- ☑ ◆ The wash basin in the hall bathroom is cracked, but not leaking. The wash basin should be monitored, and replaced if leakage occurs.

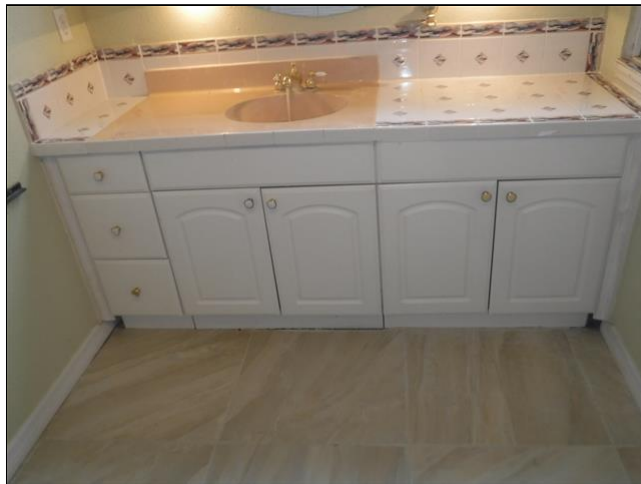
Master Bathroom

- ◆ The countertop in the master bathroom is deteriorated. This affects its appearance, and may limit its remaining useful life.

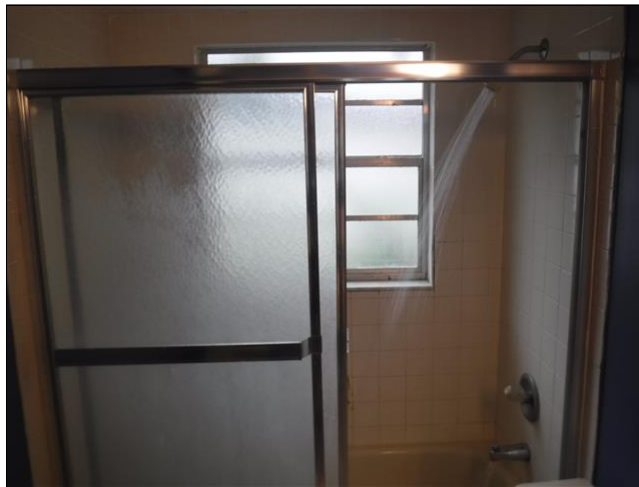
Hallway Bathroom

- ❌ ◆ A track for sliding shower doors in the hall bathroom is not fastened and moves. This allows one or both glass panels to come free and is a safety issue. Have a qualified person repair as necessary.

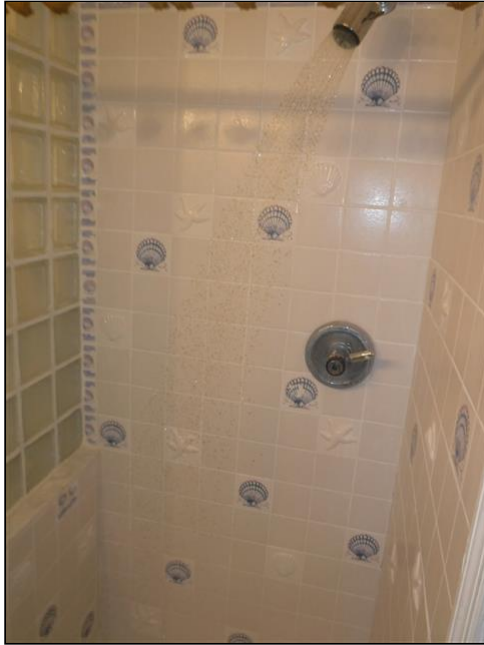
Pool bath

- ❌ ◆ The tile surround at the shower wall in the pool bath is deteriorated and needs repair or replacement. The wall board and framing may need repair (not visible). I recommend repair or replace using a qualified contractor.

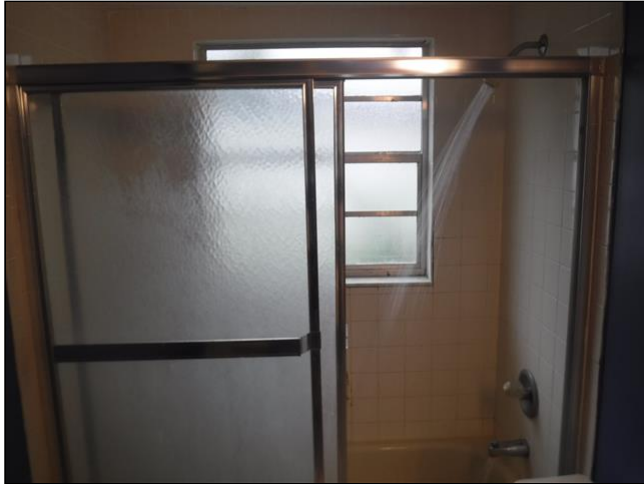
Hallway Bathroom

Caulking/Grout at the pool bath shower is cracked. Missing or deteriorated caulking can promote water penetration into the adjoining structure. The old caulking should be removed and re-caulked. NOTE: Treat the area as needed before re-caulking to prevent mildew from occurring.

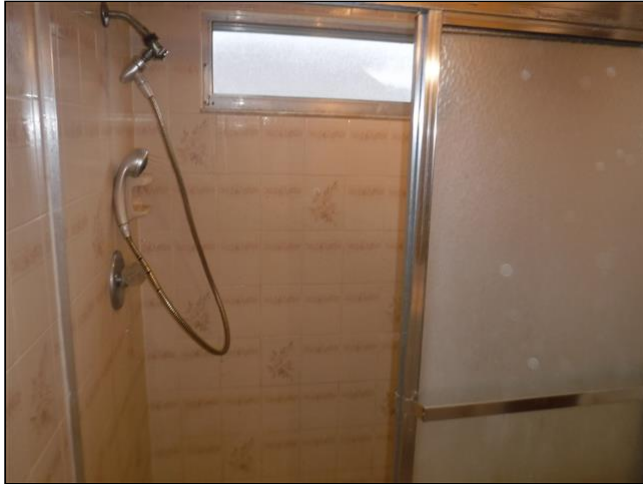
Old Master Bathroom

- ❌ ♦ The tile surround at the bathtub wall in the old master bathroom is deteriorated and needs repair or replacement. The wall board and framing may need repair (not visible). I recommend repair or replace using a qualified contractor.

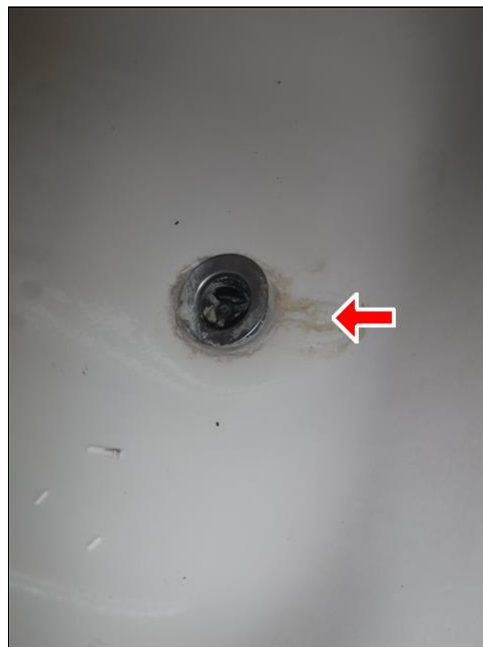
Hallway Bathroom

- ❌ ◆ The drain is damaged in the hall bathroom. This is a common condition with older tubs and repair parts may not be readily available.
