BPG Inspection, LLC

**Ashwood Drive
Tampa FL 33624**

Client(s): Jenifer
Inspection Date: 9/8/2022
Inspector: David Batha , HI8000 (FL)

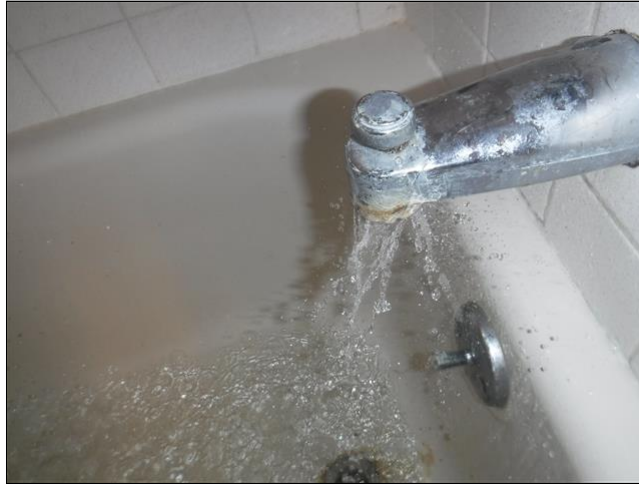
Hallway Bathroom

- ☑ ◆ The surface finish of the bathtub in the hall bathroom is marred. Sometimes, such finish damage can be patched. There are companies that specialize in the refinishing of bathroom surfaces with epoxy coatings or fiberglass repairs. Repairs may not be as durable as the original finish, but if done properly they can extend the service life of the bathtub. Consideration should be given to this type of repair as an alternative to the more expensive option of replacing the bathroom fixture.
- ☑ ◆ The shower diverter valve does not function properly in the hall bathroom. This is preventing enough water from being properly diverted to the shower head. A qualified technician could replace the diverter.

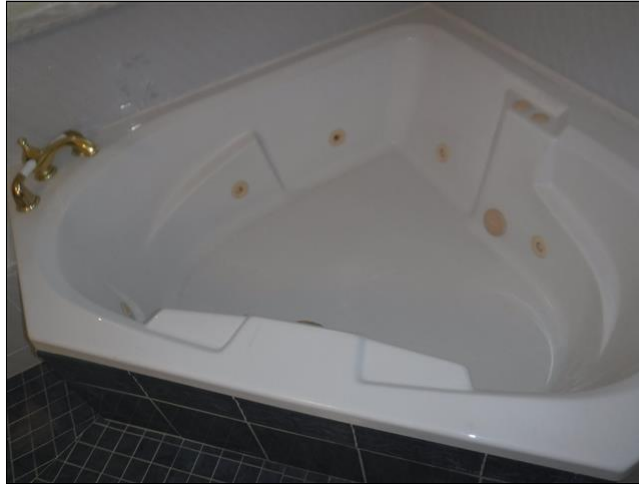
Master Bathroom

- ✘ ◆ There is no access panel for servicing the whirlpool tub mechanical equipment. If the equipment requires repair, the lack of access will result in higher repair costs. We recommend that a removable access panel be installed.
- ✘ ◆ The whirlpool tub is not functional. A qualified technician should evaluate the system and make repairs or modifications as necessary.

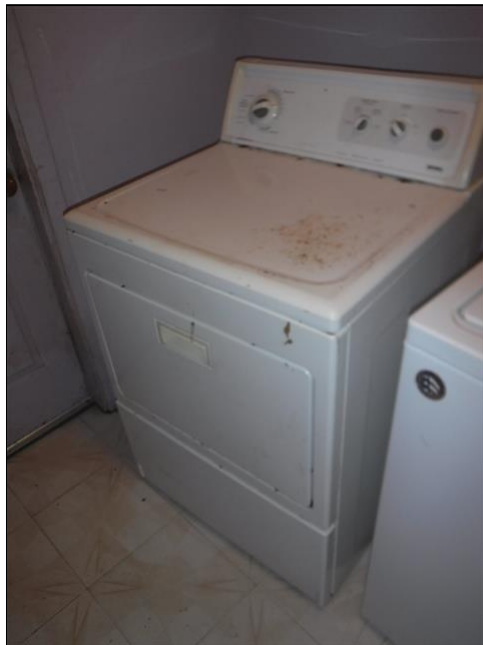
Laundry Room

♦ Although the clothes dryer is functional, it is older. Budget to replace.

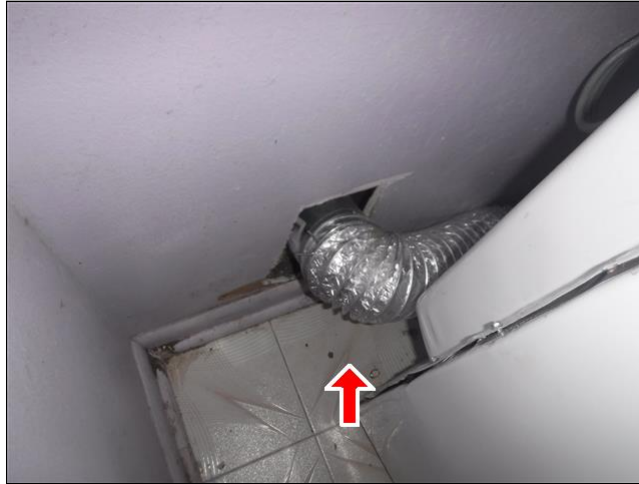
Dryer vent

♦ The dryer vent is installed through the roof. Installation in this manner makes condensation problems or lint buildup in the vent more likely. The vent should be cleaned frequently. A qualified technician could re-route the vent.

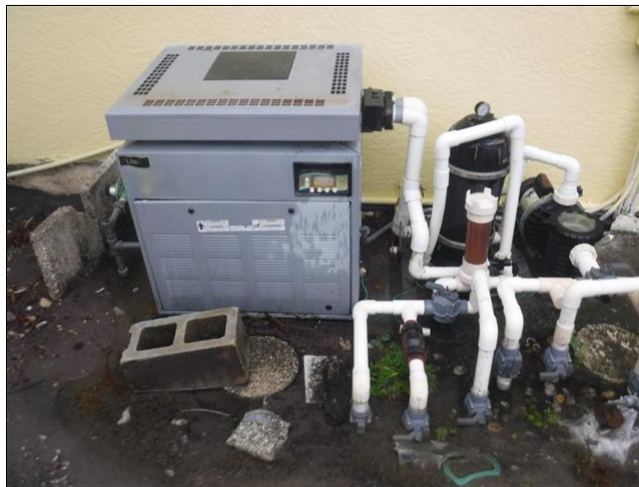
Pool Equipment

- ♦ The pool equipment appears to have settle lower into the ground as a result of the gutter downspout depositing the rain water into the area causing soil erosion and a depression around the pool equipment.

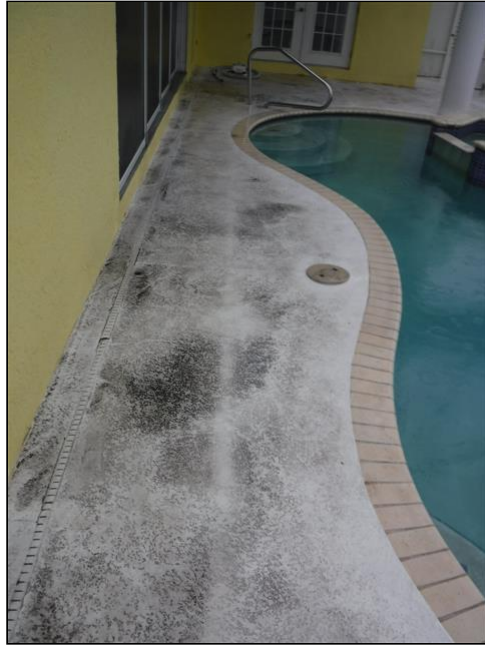
Pool & Spa

- ♦ The pool and or spa decking shows typical cracks and wear. Any missing, chipped or cracks are cosmetic and can be repaired.

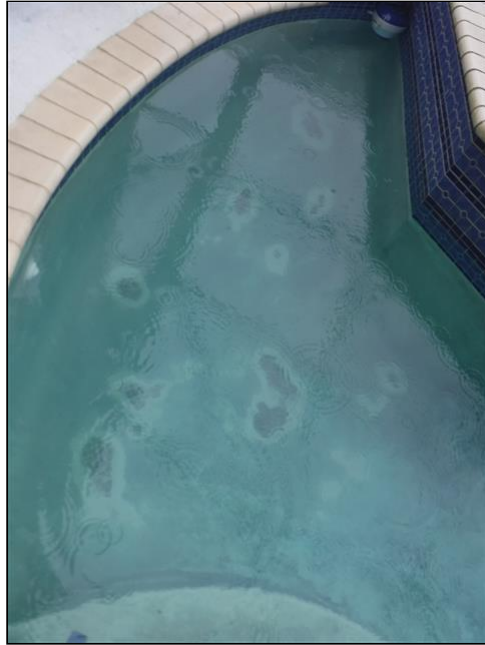
Pool & Spa

- ◆ The pool / and or spa surface material is in replacement condition. Consult a qualified pool professional to estimate replacement costs.

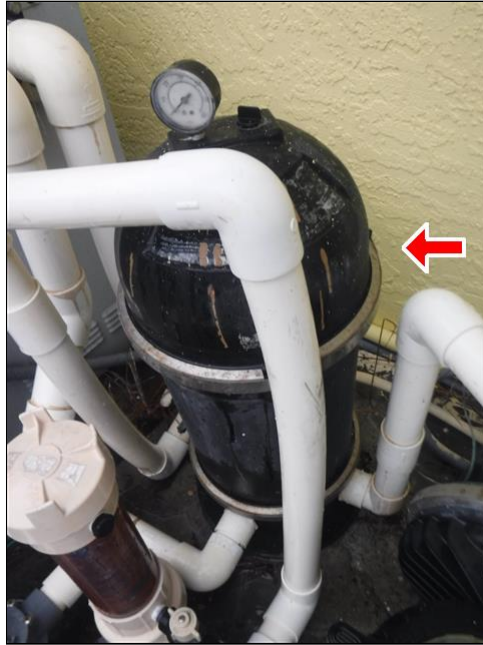
Pool Equipment

♦ The filter is not working and should be replaced by a qualified pool professional as needed.

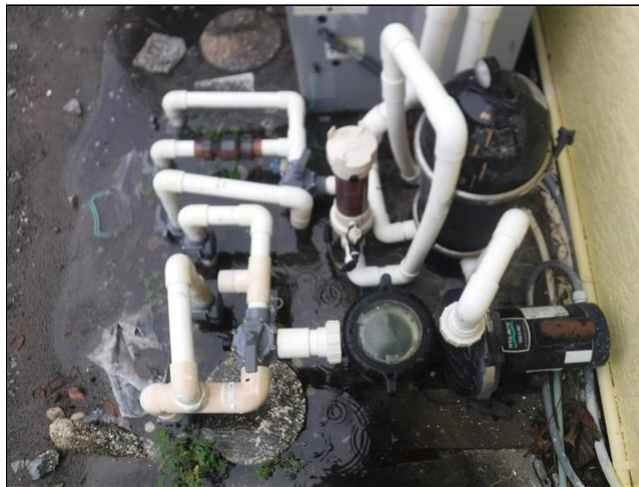
Pool Equipment

- ◆ All exposed plastic piping should be painted or shaded in accordance with industry standards to prevent deterioration or damage.

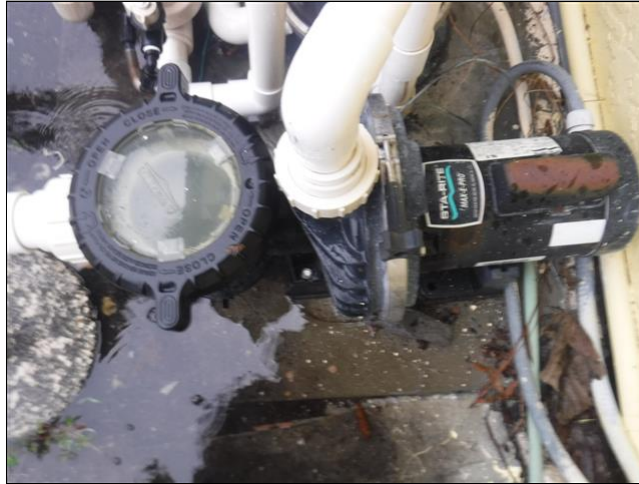
Pool Equipment

- ◆ The pool and/or spa pump did not respond to normal operating controls. A qualified pool technician should repair or replace the pump.

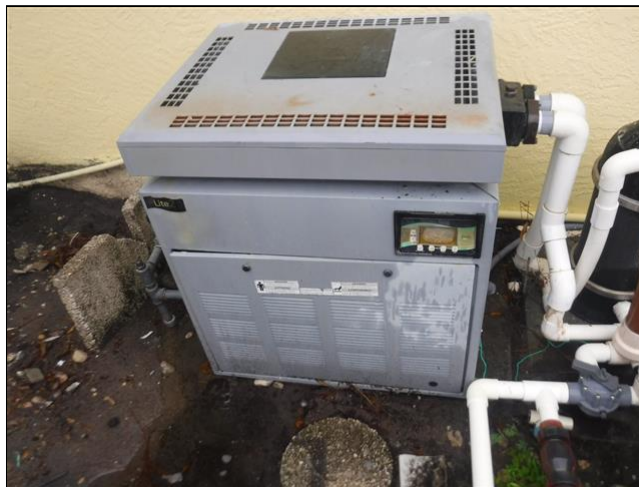
Pool Equipment

♦ The heating system was not functional. A qualified technician could make repairs or modifications as necessary.
